Restoration of longitudinal connectivity and salmonid habitat in River Mörrumsån (Sweden)

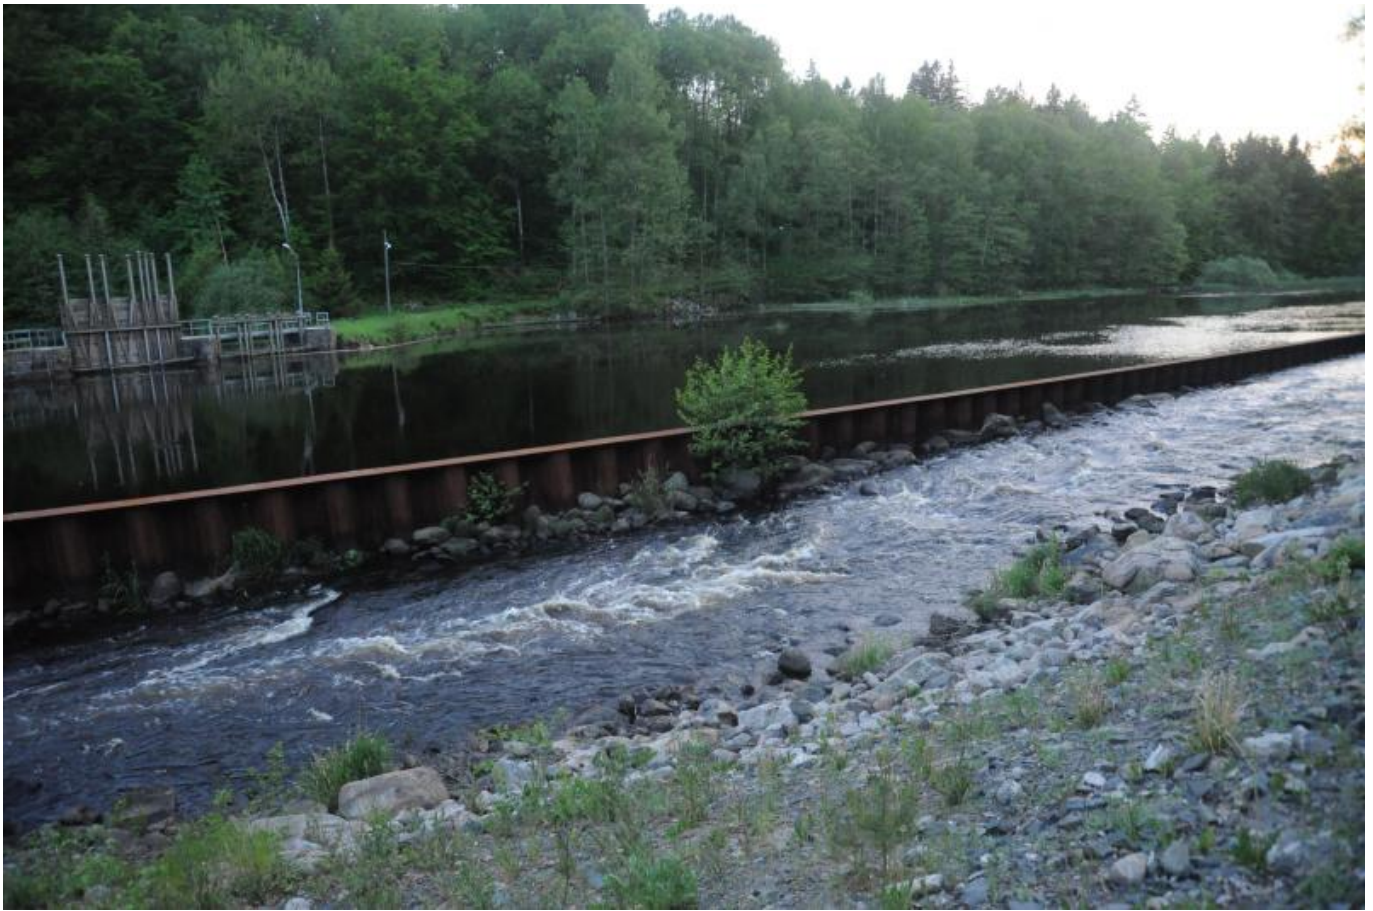
Figure 2. Nature-like partial width rock ramp constructed at Hemsjö nedre hydropower dam in River Mörrumsån in 2003-2004. Photo by Frauke Ecke, SLU.

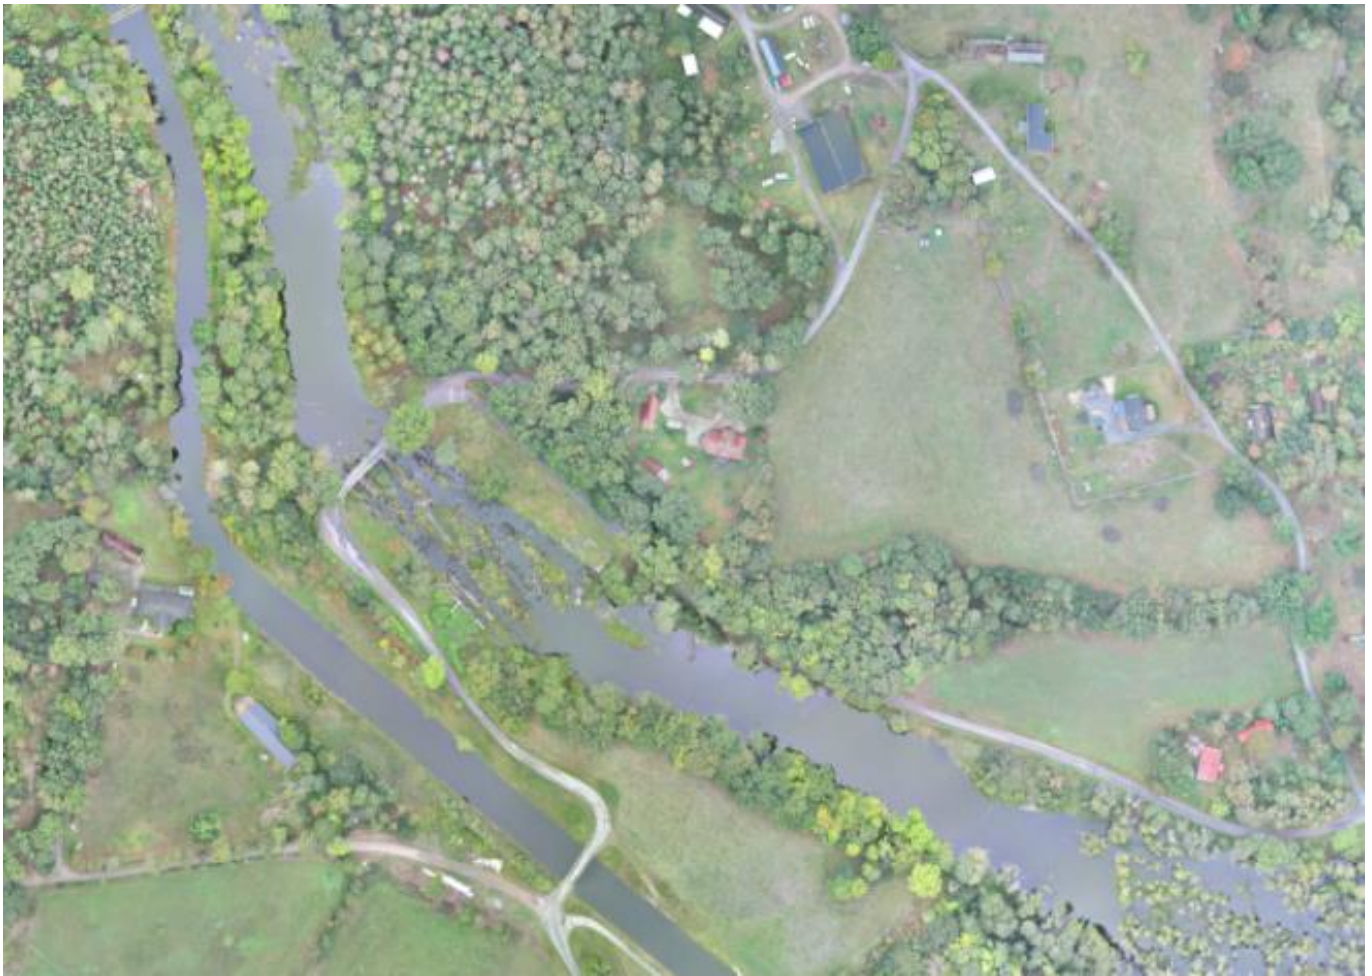
Figure 3 + Figure 4: Overview of parts of the restored stretch in River Mörrumsån (left), also visible is the man-made channel feeding the Hemsjö övre hydropower station. To the right a photo of a restored stretch during a flow episode when more than the dictated minimum flow of 1 m³/s has been directed through the natural channel. Salmonid spawning gravel was added here in 2010. Photos by Frauke Ecke, SLU.

The cost for these restoration measures and the reduction of hydropower output in the affected stations was shared by the partners of the interest group. The River Mörrumsån Fish Conservation group has remained active after the initial restoration measures. This has facilitated e.g. the installation of automatic fish counters at the Marieberg and Hemsjö övre fishways as well as the addition of hundreds of cubic meters of salmonid spawning gravel to areas in the former dry channel between Hemsjö nedre and Hemsjö övre and to other stretches of the river in 2004, 2005, 2006, 2010 and 2012 (figures 3 and 4).
