REFORM

REstoring rivers FOR effective catchment Management

Deliverable D2.1 Part 3

Title Catchment Case Studies: Full Applications of the Hierarchical Multi-scale Framework

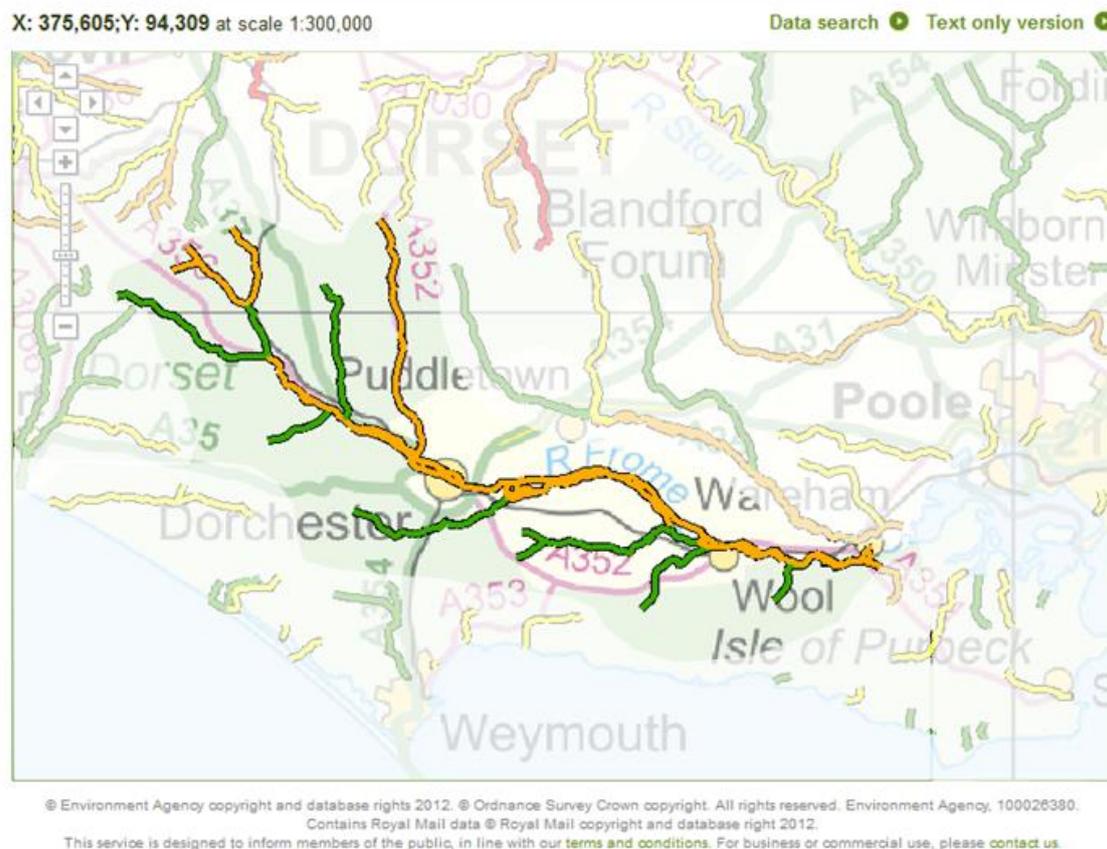
Figure 1.1 Current ecological status of waterbodies in the River Frome catchment. Yellow: poor ecological status, green: good ecological status. (What's in your backyard? Online mapping tool, maps.environment-agency.gov.uk. Environment Agency copyright and database rights 2012 and Ordnance Survey Crown copyright).

Whilst the River Frome has historically supported diverse ecological communities and productive fisheries, concerns have been raised about ecological degradation in the system. In fact, the ecological status was classified as poor for most of the main river in the first WFD assessment cycle (Figure 1.1). Of the 4 WFD waterbodies on the main stem of the River Frome, three are rated as poor and the fourth is classified as heavily-modified (Table 1.1). The majority of the tributaries are classified as having good ecological status (6), though 2 are in poor condition and 1 is heavily-modified (Figure 1.1).

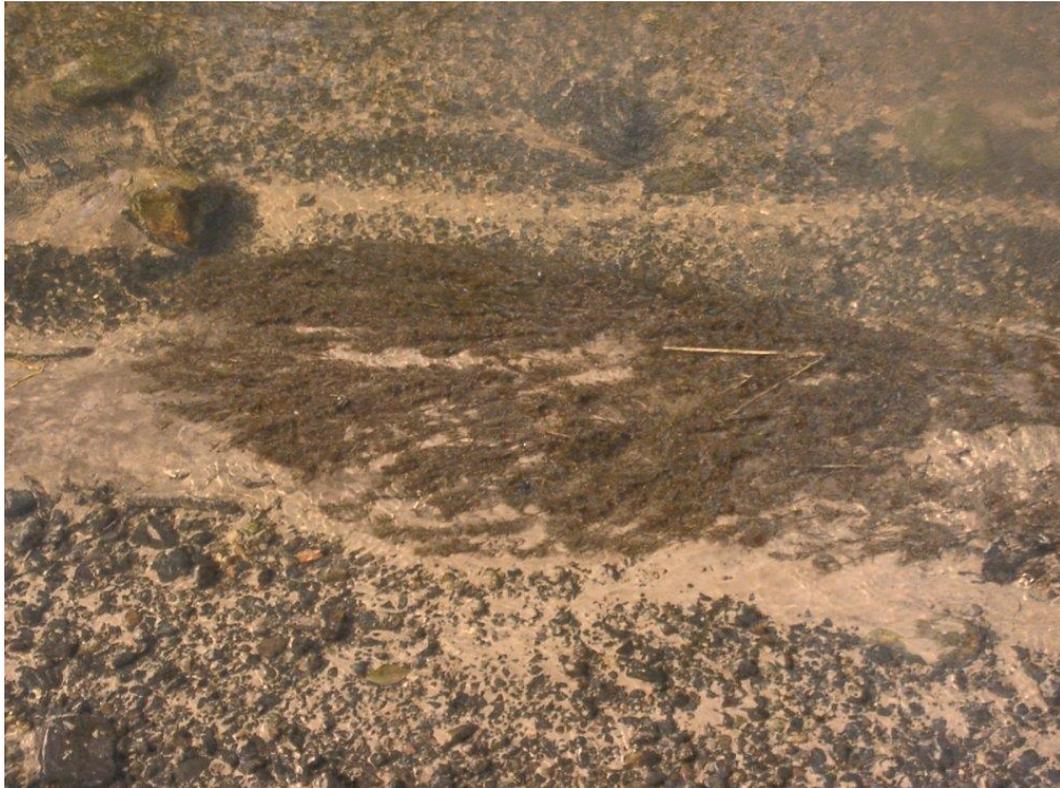
Figure 4.16 Fine sediment deposited on and within the surface layers of the River Frome’s gravel bed in Reach 5.

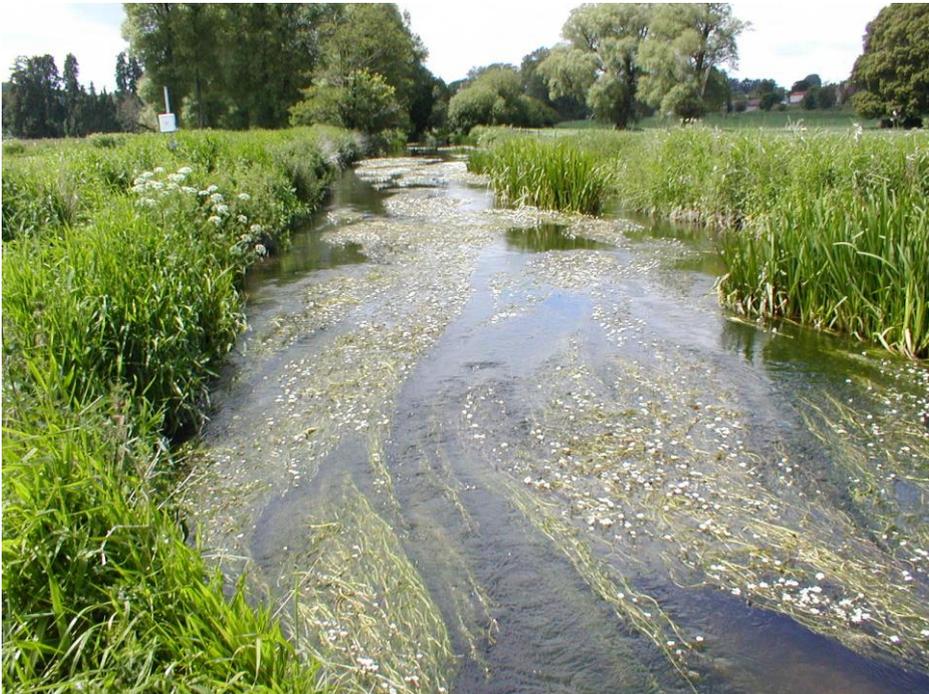
Figure 4.28 Patchy distribution of emergent macrophytes (mainly *Sparganium erectum*) and submerged macrophytes (mainly *Ranunculus penicillatus* ssp. *Pseudofluitans*) in a part of Reach 6

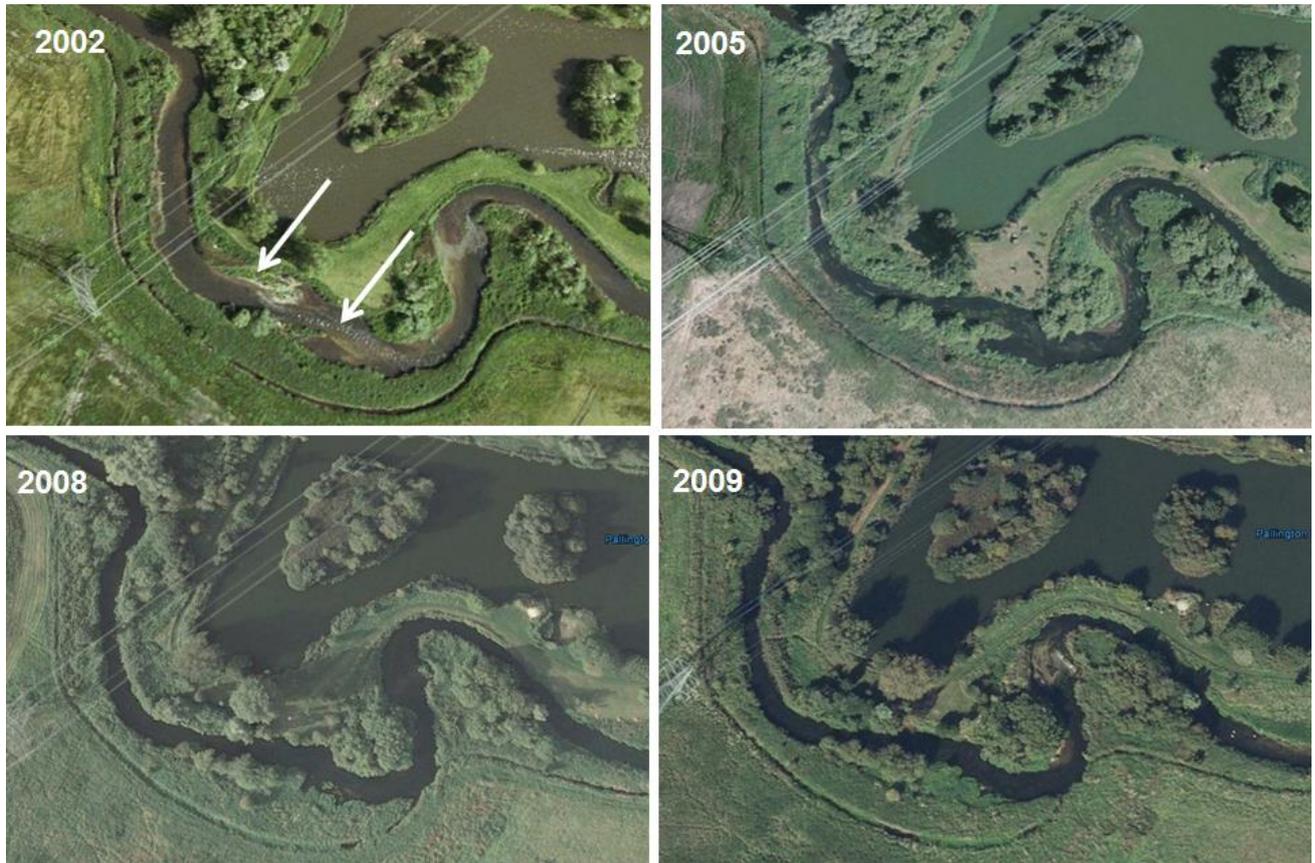
Figure 4.39 Vegetated sedimentary features within the channel in Reach 14 identified from successive aerial images, which have resulted in planform change (© Google Earth, Getmapping, Infoterra and Bluesky).

Vegetation encroachment was significant in the downstream section of the area of reach 4 that was surveyed. Here, the branches of riparian trees were rooting into the river bed and retaining fine sediment, although this was usually accompanied by erosion of the opposite bank, indicating channel migration rather than narrowing. Additionally, potential vegetation encroachment was observed from aerial images of Reaches 11-14 between 2000 and 2009 from a time series of aerial images (e.g. Figures 4.39 and 4.40).

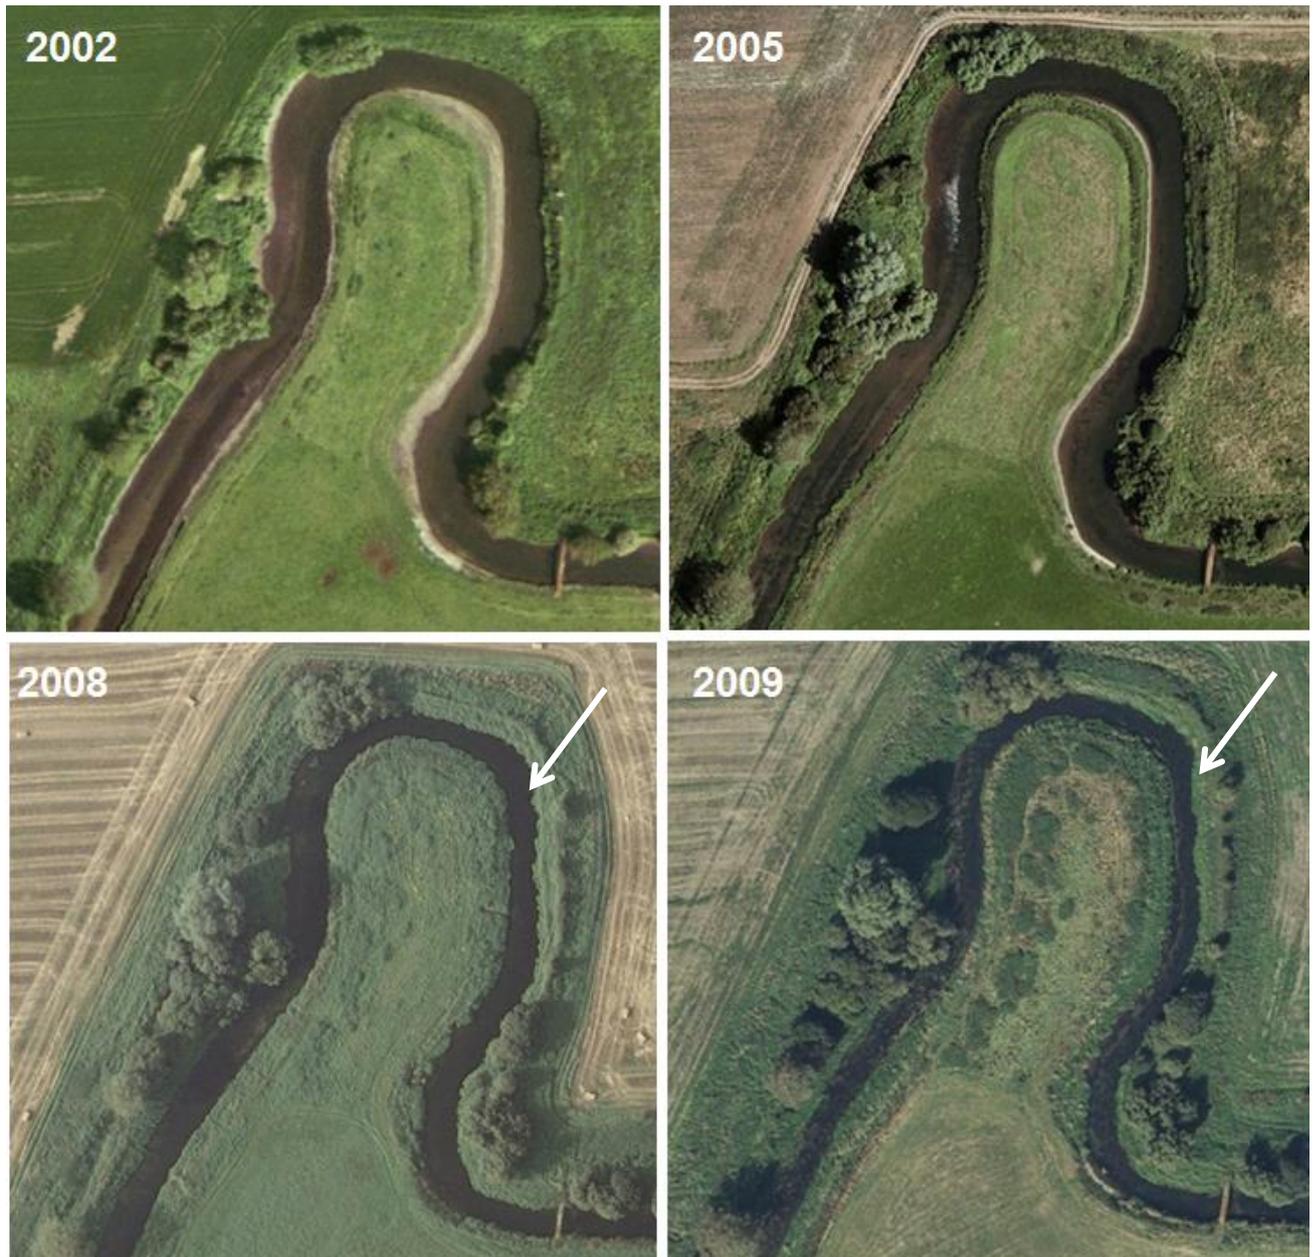
Figure 4.40 Encroachment of the channel by marginal aquatic vegetation in Reach 12. (© Getmapping, Infoterra and Bluesky).

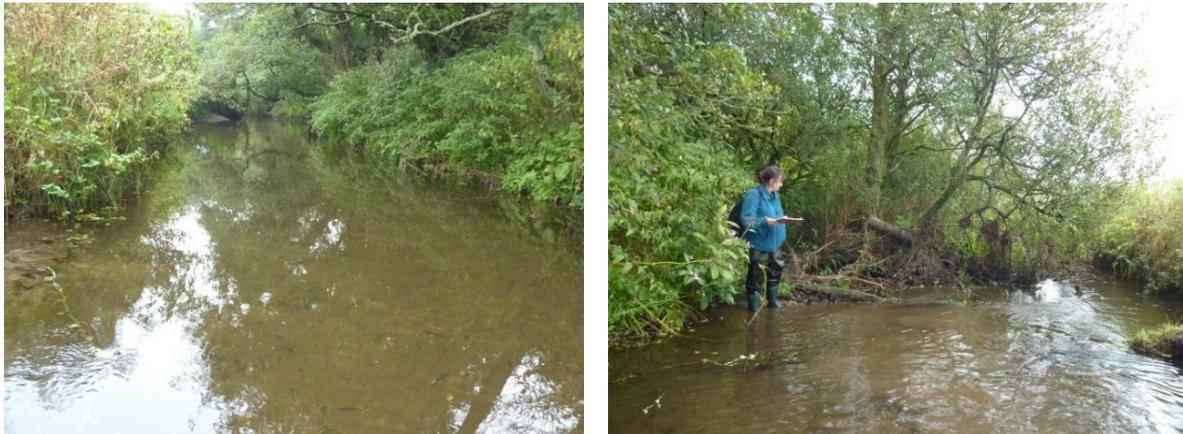
Figure 4.41 The River Frome in Reach 4. Left: Photo facing upstream towards a section of river with limited influence by riparian vegetation and large wood. Note: the channel is shallow and has a thick and uniform covering of fine sediment over the gravel bed (channel is ca. 5 m wide). Right: Facing downstream at the same location towards a section with natural riparian vegetation that is interacting with fluvial processes. Note: the large wood and tree jam on the left bank that is narrowing the channel and directing it towards the right bank. A riffle composed of clean gravel/cobbles has formed in the narrowed channel.

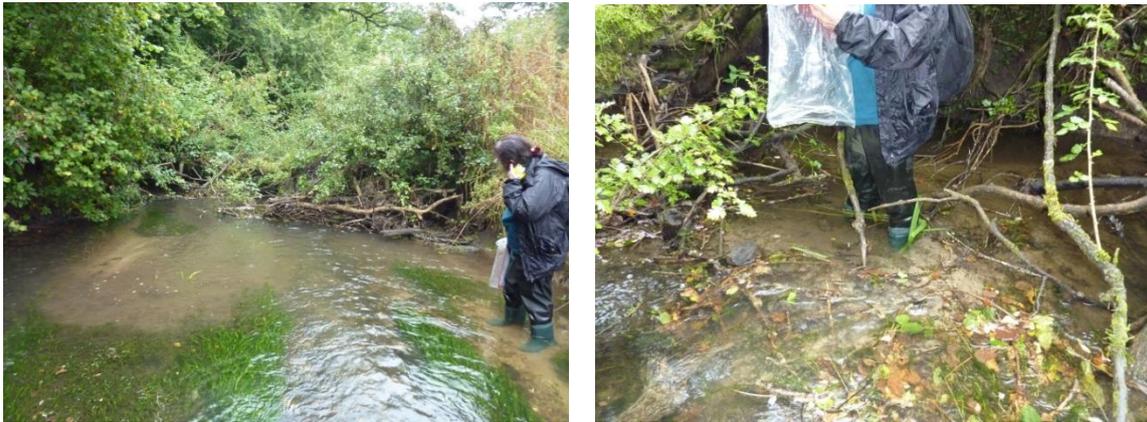
Figure 4.42 Left: A large wood jam complex. Note: flow is directed to the left bank producing high flow velocities and scouring a pool. Right: Fine sediment deposition downstream of the wood jam on the right bank.

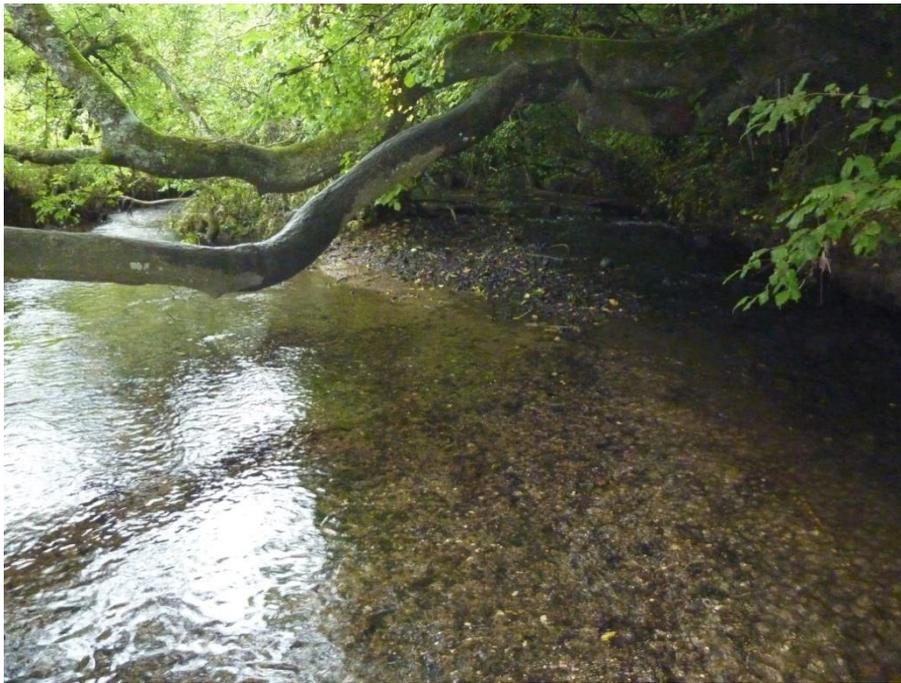
Figure 4.43 Gravel bar formed downstream of a living tree branch that is in contact with the river bed. Note: the reduced channel width on either side of the bar has increased flows and produced riffles (Photo facing upstream).

The high suspended sediment loads in the river (Section 7.3.2) and vegetation-induced fine sediment geomorphic features observed in the field in Reaches 3, 4 (Figures 4.44 – 4.47) and 5 indicates that fine sediment is being retained by vegetation to contribute to channel planform changes, through narrowing and lateral migration of the channel and the formation of lateral and mid-channel bars, benches and islands.

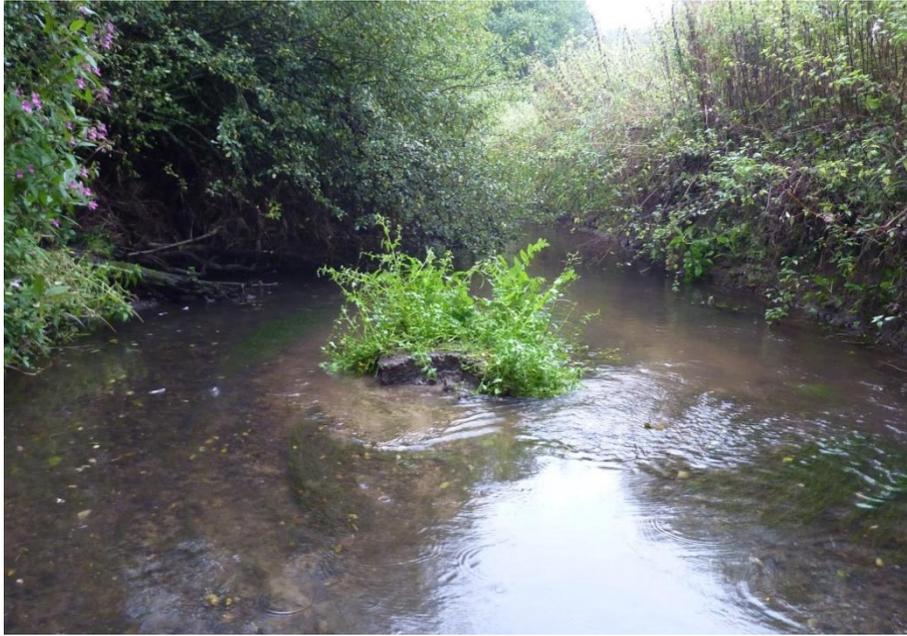
Figure 4.44 A vegetated bar (incipient island) that developed as follows: submerged *Ranunculus* sp. patch accumulates fine sediment (sand and silt), other aquatic vegetation colonise the nascent bar and induced further fine sediment accumulation (dark fine sediment layer) (Photo facing downstream).

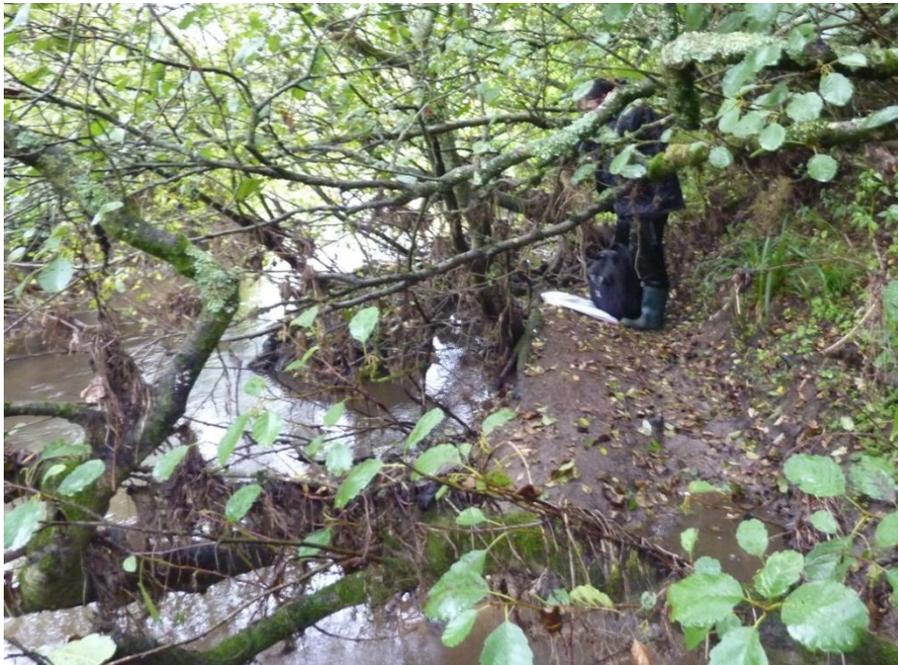
Figure 4.45 Bench on left bank downstream of large wood and above and lateral to a living riparian tree (Photo facing upstream).

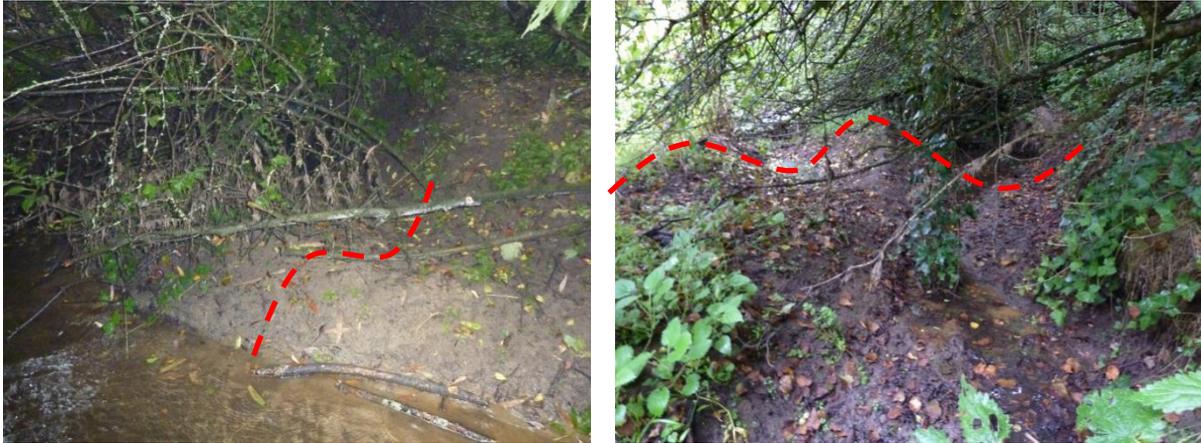
Figure 4.46 Ridged bench structures formed downstream of riparian trees and wood jams. Left: Bench with scroll-like forms on its surface on the left bank of the river. Right: A separate bench further downstream with multiple scroll-like forms on the left bank. The photo is facing upstream and the river is to the left of the picture (Photos facing upstream).

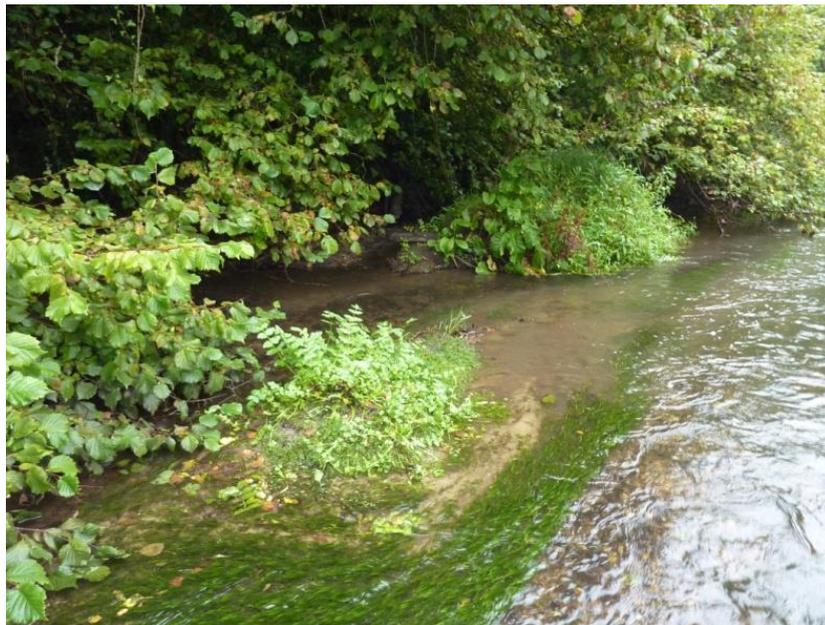
Figure 4.47 Two depositional forms induced or stabilised by vegetation. In the lower portion of the photo, a small vegetated bar is visible within a *Ranaunculus* stand. In the upper portion of the image, a ridged bench has been stabilised by vegetation, and fine sediment behind the ridge has been scoured to form a small vegetated island (Photo facing downstream).

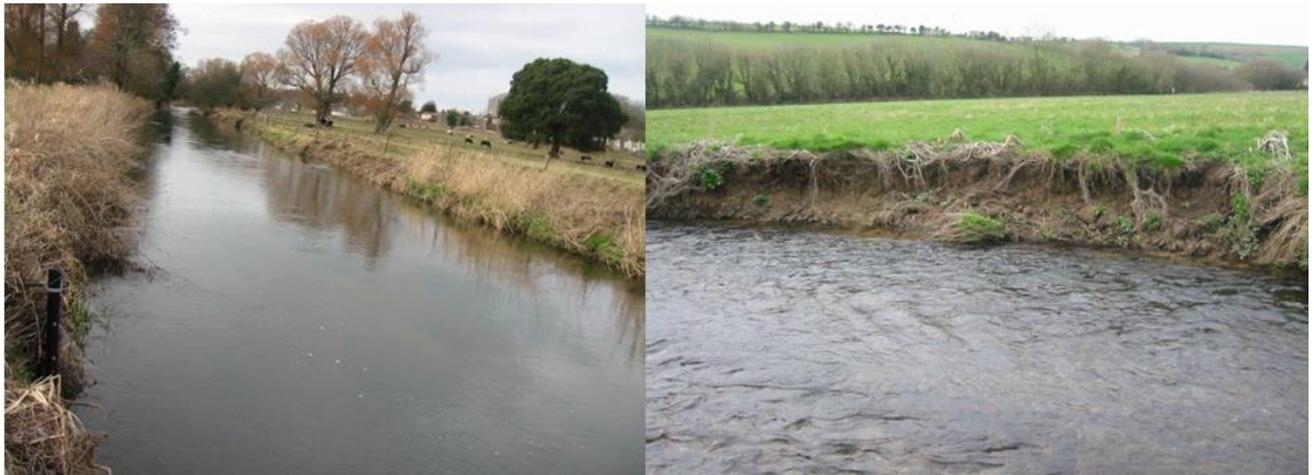
Figure 4.51 Examples of steep bank profiles in Reaches 5 and 6

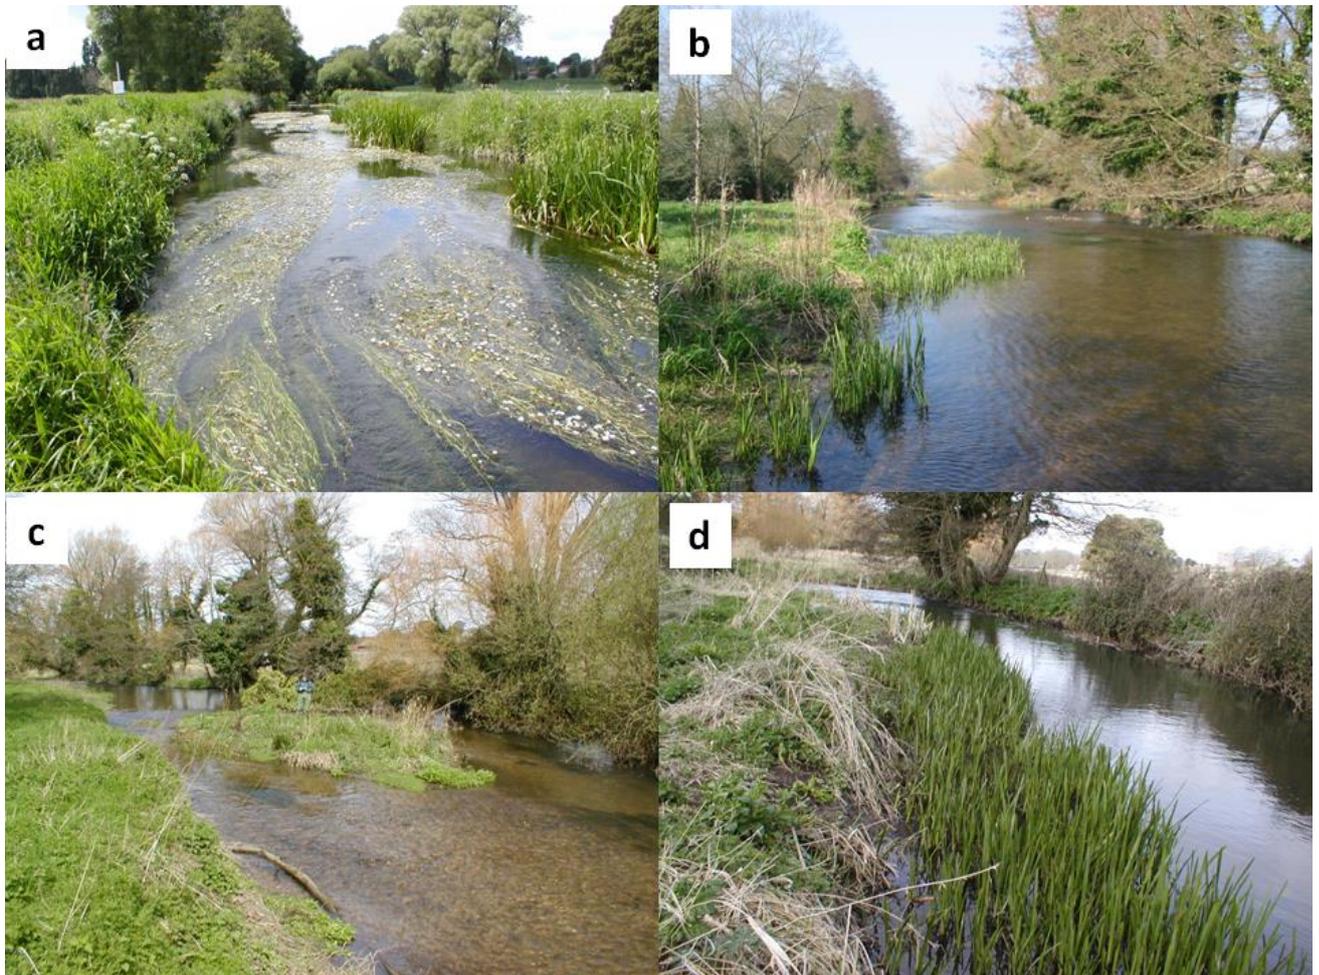
Figure 8.5

- a) Extensive macrophyte cover in the downstream unshaded part of reach 6 in mid-summer**
- b) Patches of emergent macrophytes in unshaded areas of a tree lined part of reach 6, immediately downstream of the road bridge crossing. Note the gentle bank profile adjacent to the macrophyte stands indicating bank accretion through bench development and extension associated with the emergent macrophytes.**
- c) Island developing on a mid-channel bar, now covered by riparian vegetation but probably initiated by emergent macrophytes.**
- d) Bank extension led by macrophyte sediment trapping.**

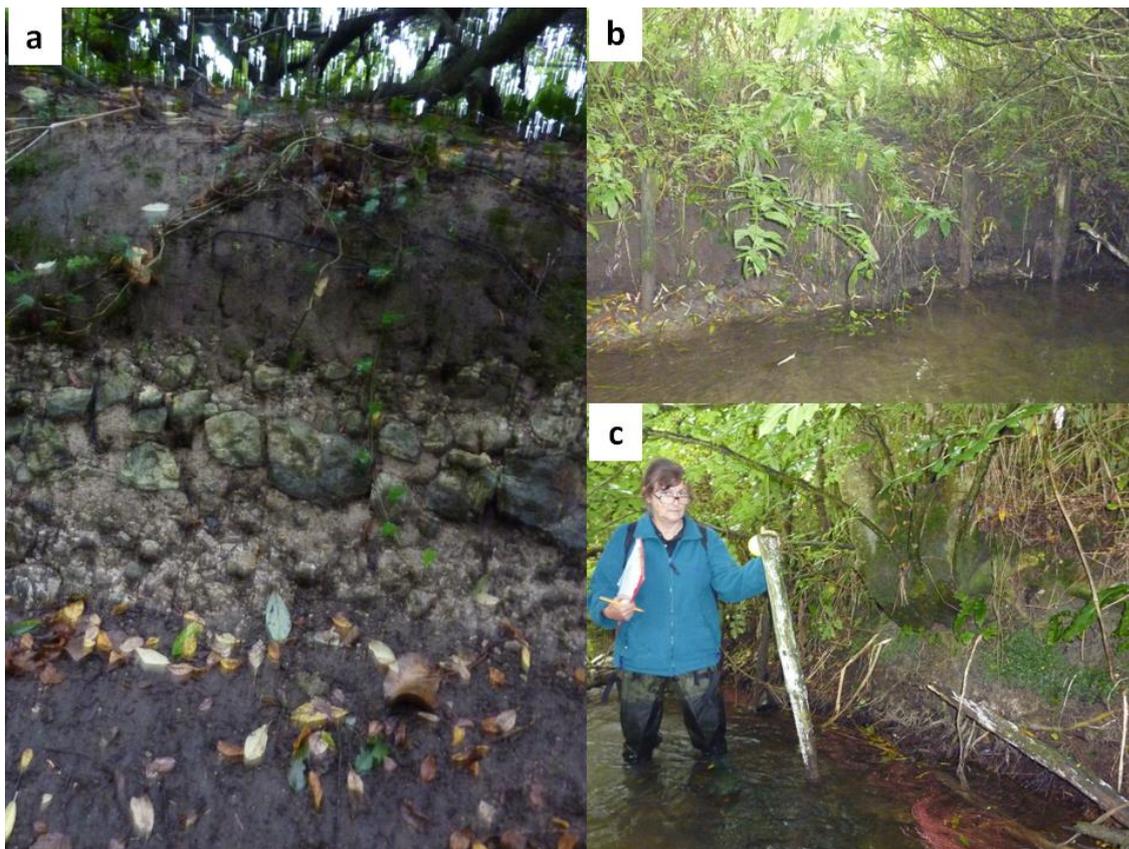
Figure 8.11 Exposures of old bank reinforcement: a) stones, b) wooden stakes facing the bank, c) wooden stakes exposed by bank erosion and retreat.

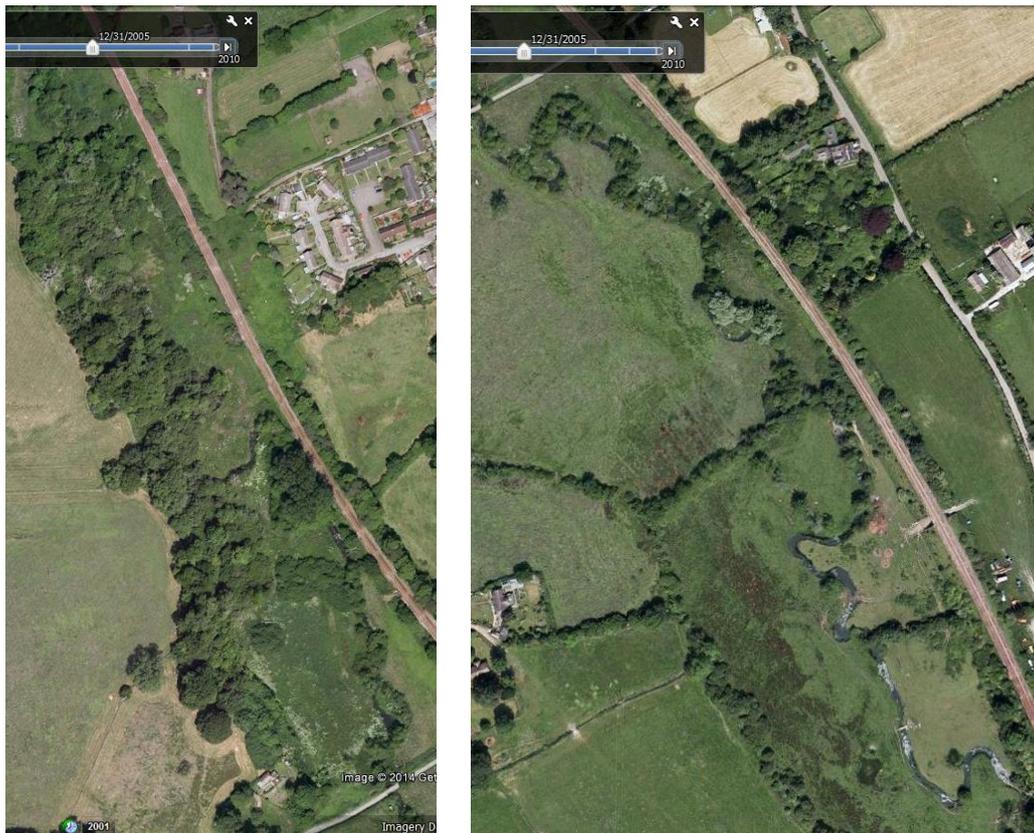
Figure 8.16 Aerial photographs showing (left) the naturally functioning riparian vegetation in the upstream half of Reach 3, and (right) the isolated trees and riffle sequence along the lower half of the reach (Google Earth, © 2014 GetMapping).

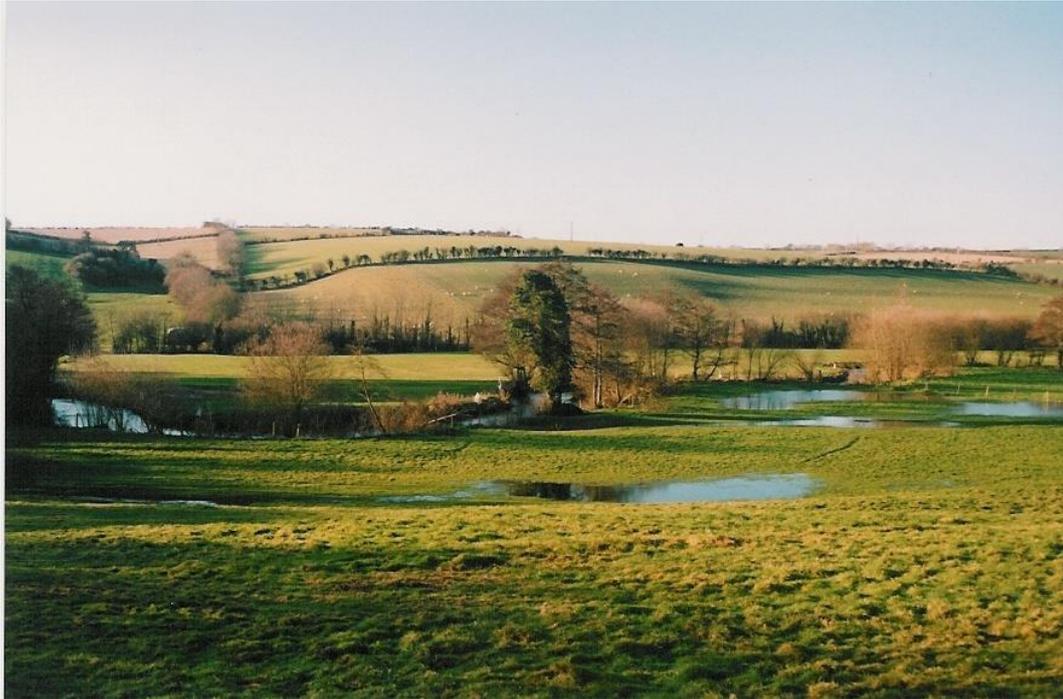
Figure 8.21 Meandering section of reach 5 in early spring, facing south. Note the old channels picked out by floodwater on the floodplain and the line of riparian trees along the near (left) bank (the river flows from right to left of the photograph).

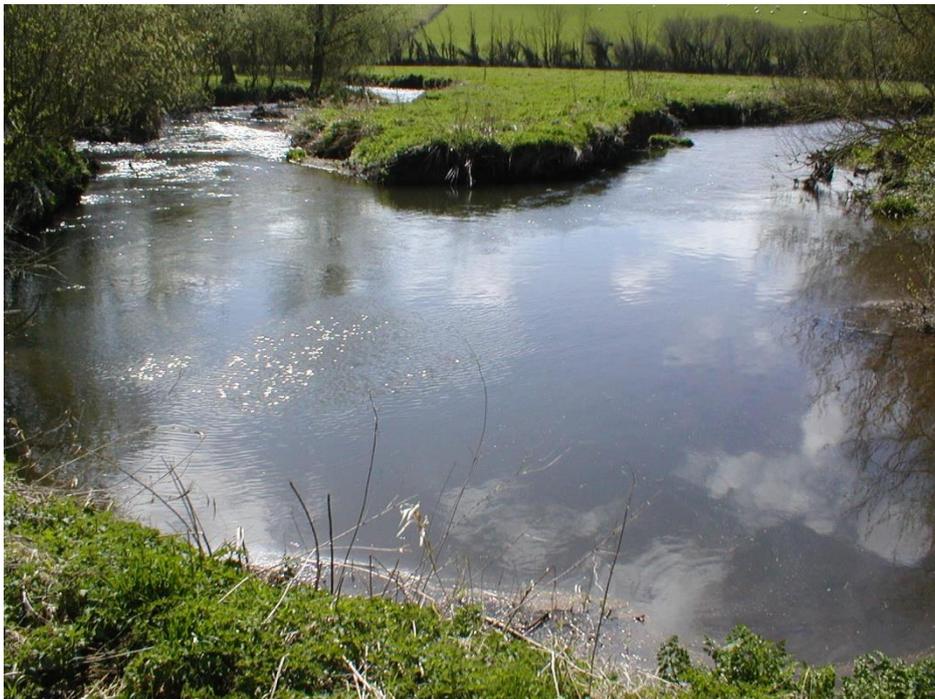
Figure 8.22 Meandering section of reach 5 in early spring, facing south at the apex of the meander. Note the deep pool at the bend apex and riffle downstream (left); eroding banks on the upstream side of the meander neck (right) and aggrading banks and mid-channel bars on the downstream side of the meander neck.

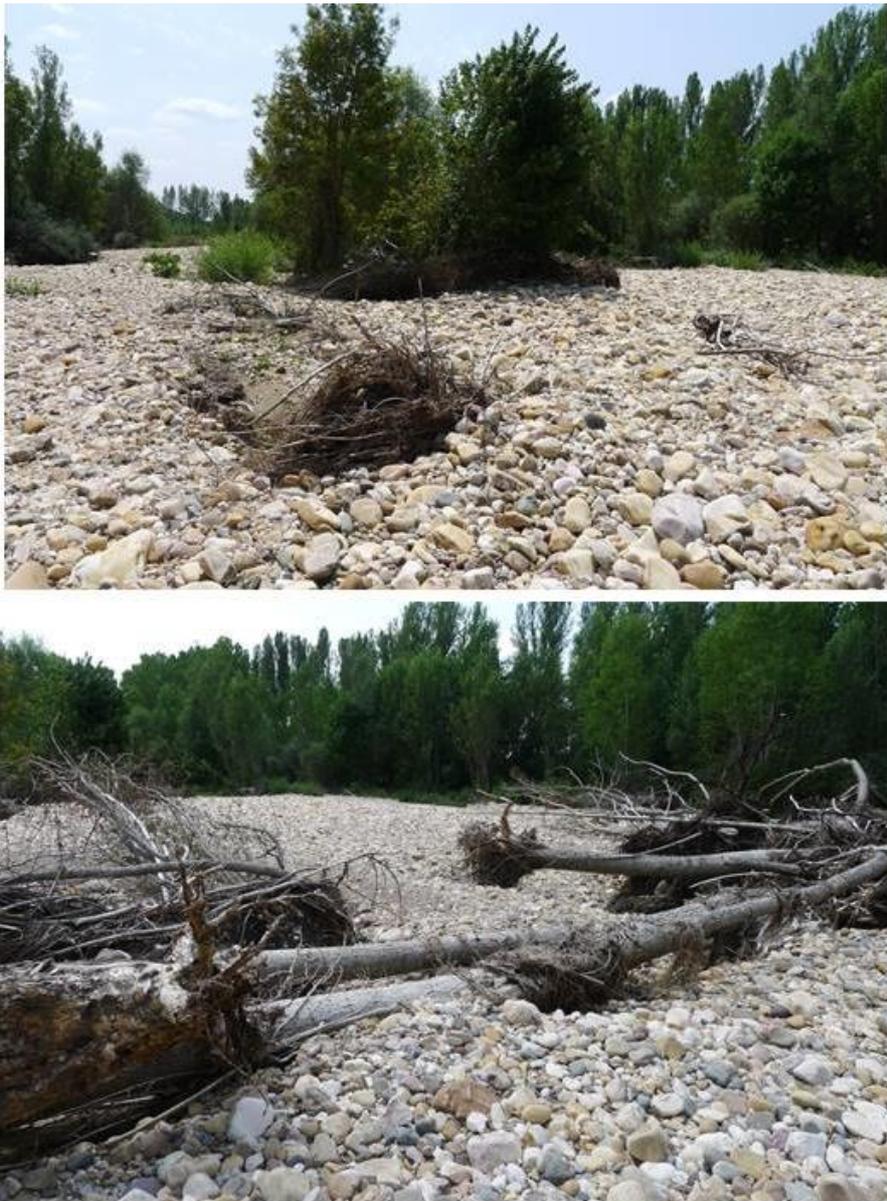
Figure 5.1 View of the Curueño river in segment 3 after large floods occurred at the end of the last winter, 2014.

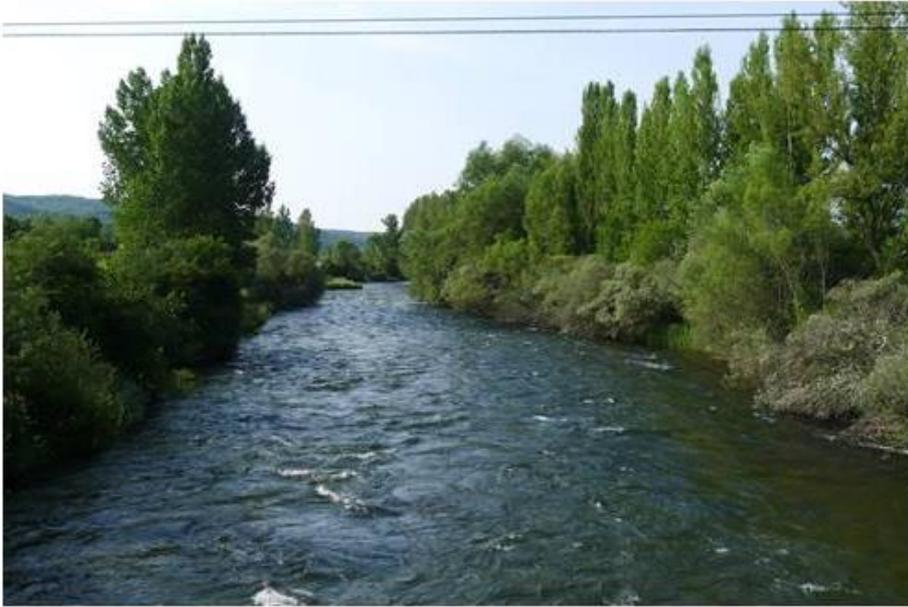
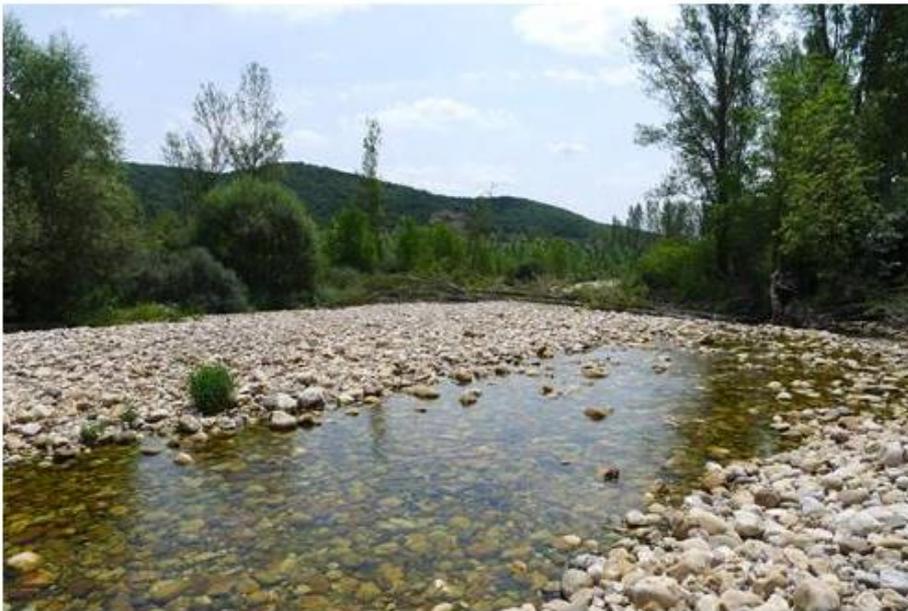
Figure 5.2 Channel and riparian conditions in July, 2014 of the studied rivers. a) River Porma at reach 3, showing high flows released from the reservoir for irrigation and totally vegetated river banks. b) River Curueño at reach 4 showing natural low flows during summer time and unvegetated coarse sediment bars attached to channel banks.

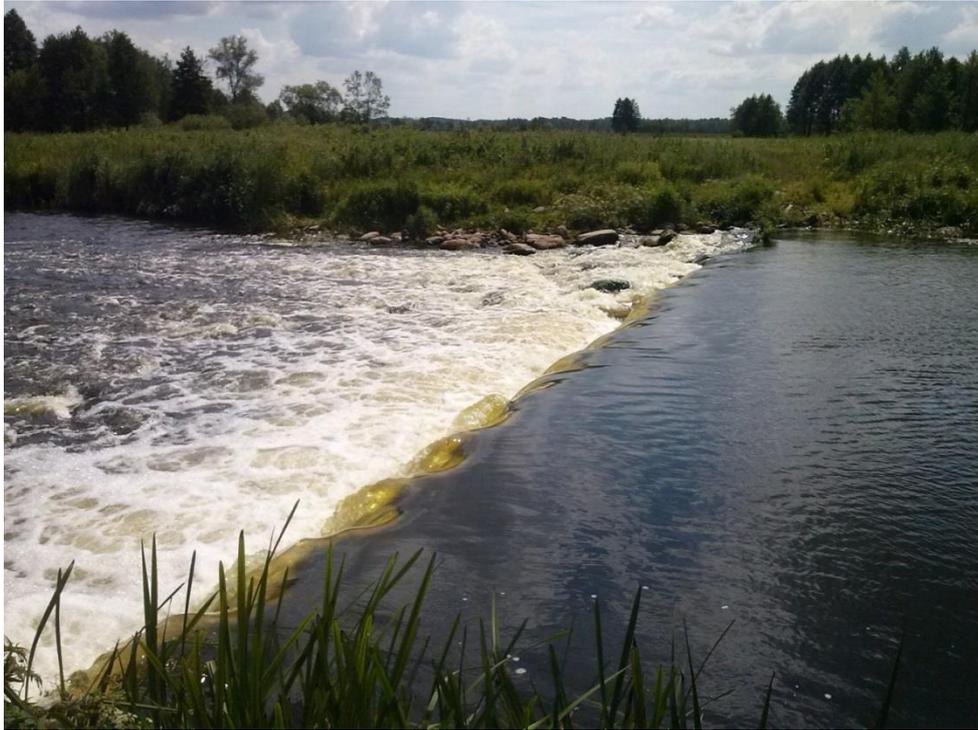
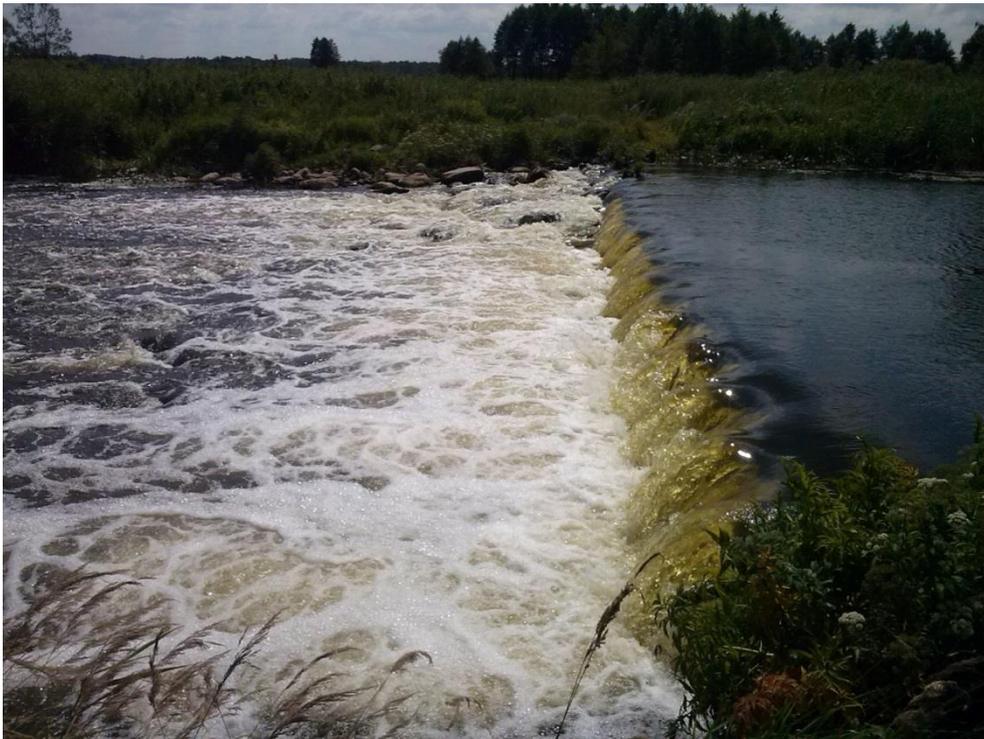
Figure 4.13 One of the two significant blocking structures found in Segment 6.

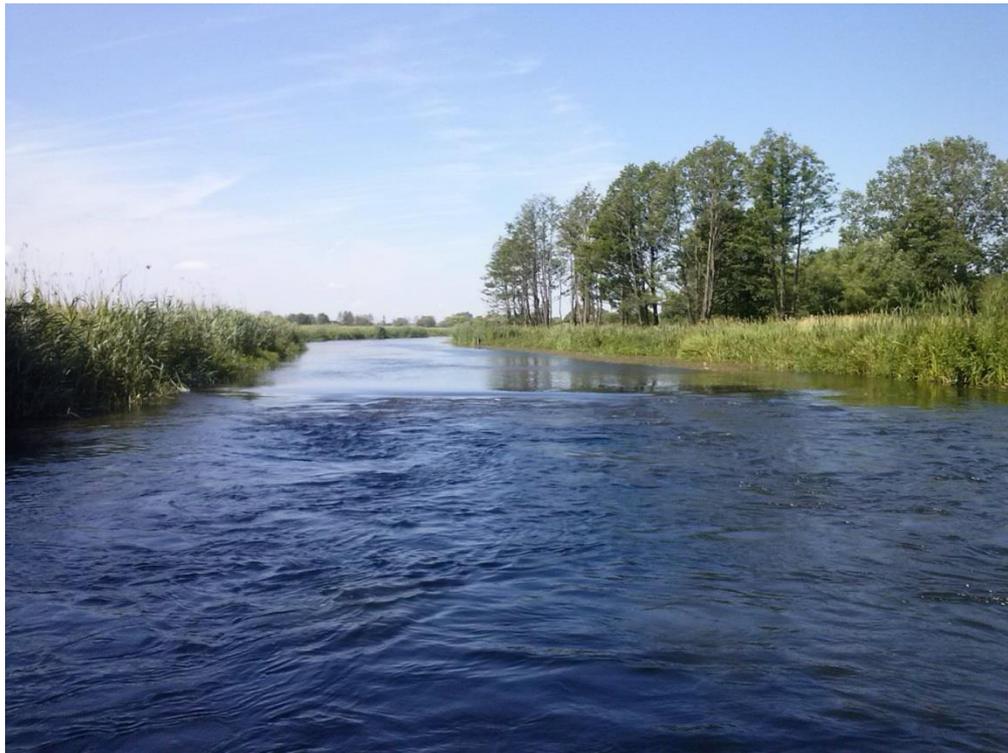
Figure 4.14 Example of visible effect of relict dam now entirely underwater.

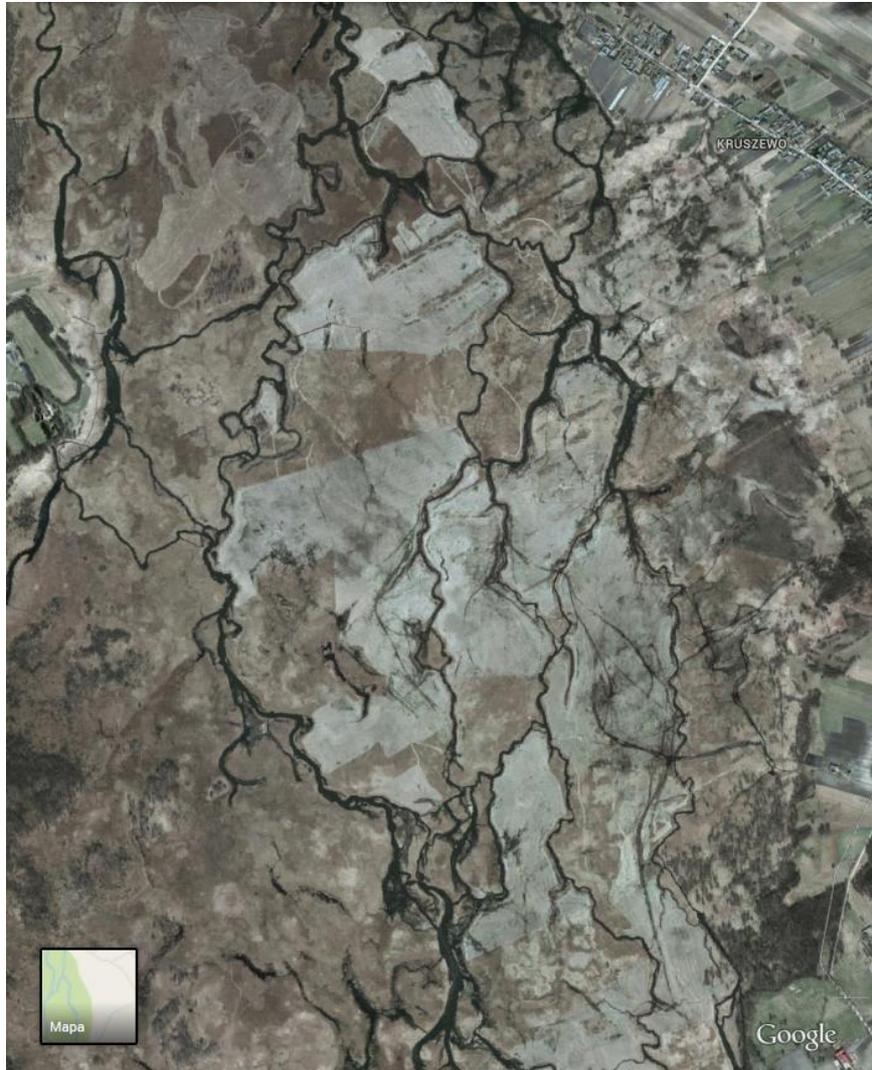
Figure 4.16 The multi-thread character of the River Narew (a part of the Reach 29) (source: <http://google.maps.pl>).

Reach-level characterisation focuses on the anastomosing section of the river located within Narew National Park, which comprises 5 reaches in segment 6 (Figure 4.16).

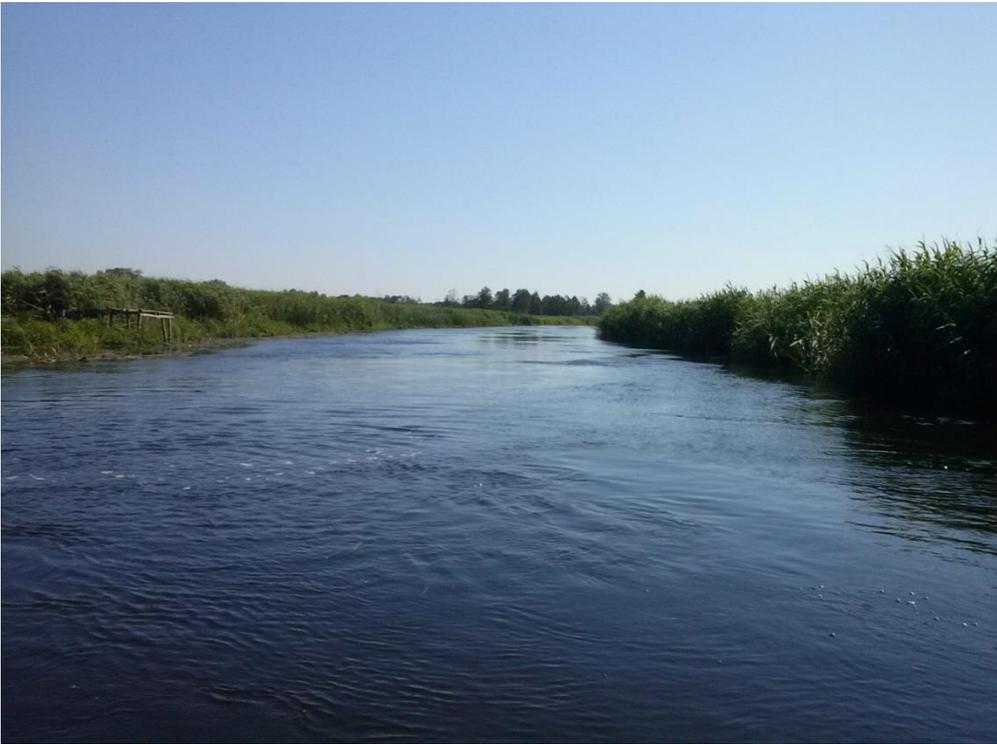
Figure 4.19 An example of typical wide main channel in Reach 29. The channel is 4 m deep, free of aquatic vegetation, and bordered with common reed.

The abundance of aquatic vegetation in river channels depends on the water depth and current velocity. Active channels deeper than 2 m are free of vegetation (Figure 4.19) but shallower stretches are promptly colonized (Gradziński et al. 2003) (Figures 4.20, 4.21). The first species which appears is arrowhead (*Sagittaria sagittifolia*), an emergent herbaceous perennial plant, commonly growing in standing, or slow-moving water, from 10–50 cm deep) followed by perennial Yellow Water-lily (*Nuphar lutea*), which grows in shallow water and wetlands, with its roots in the sediment and its leaves floating on the water surface: it can grow in water up to 5 metres deep. Sluggish-water and inactive channels are rather densely covered with numerous species of aquatic plants. Especially abundant is water soldier (*Stratiotes aloides*), a submerged aquatic perennial plant, accompanied by common frogbit (*Hydrocharis morsusraeanae*), which can be a submerged or floating aquatic perennial plant, and common duckweed (*Spirodela polyrhiza*), a perennial aquatic plant usually growing in dense colonies that form a mat on the water surface.
