REFORM

REstoring rivers FOR effective catchment Management

Deliverable D2.1 Part 3

Title Catchment Case Studies: Full Applications of the Hierarchical Multi-scale Framework

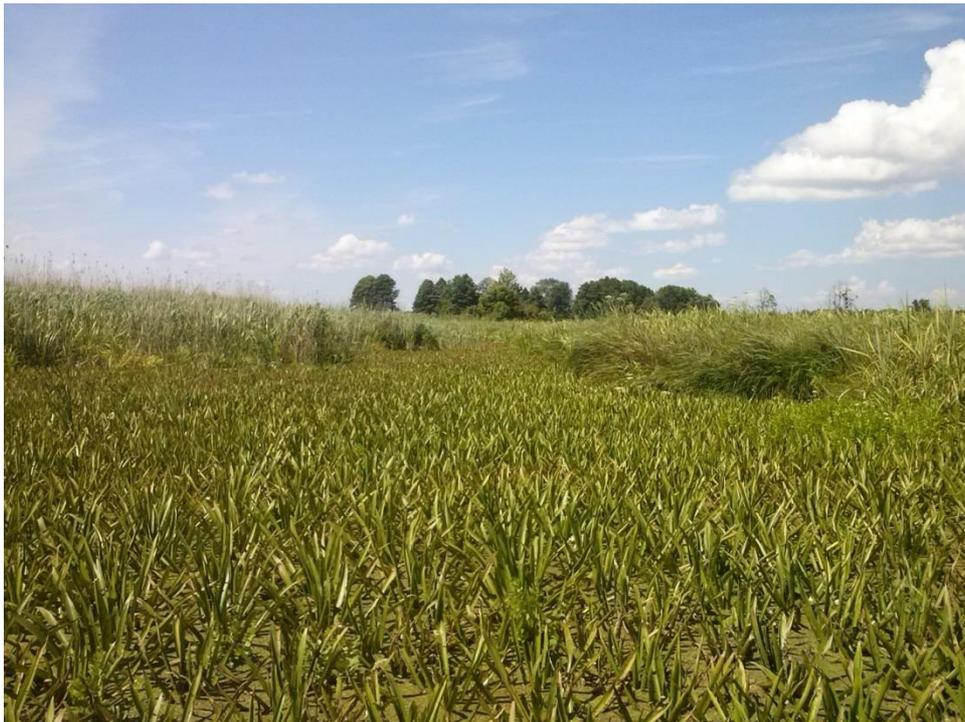
Figure 4.21 An example of a shallow side channel completely colonized by water soldier (*Stratiotes aloides*). (In the active channel, water depth reaches 0.5m).

The abundance of aquatic vegetation in river channels depends on the water depth and current velocity. Active channels deeper than 2 m are free of vegetation (Figure 4.19) but shallower stretches are promptly colonized (Gradziński et al. 2003) (Figures 4.20, 4.21). The first species which appears is arrowhead (*Sagittaria sagittifolia*), an emergent herbaceous perennial plant, commonly growing in standing, or slow-moving water, from 10–50 cm deep) followed by perennial Yellow Water-lily (*Nuphar lutea*), which grows in shallow water and wetlands, with its roots in the sediment and its leaves floating on the water surface: it can grow in water up to 5 metres deep. Sluggish-water and inactive channels are rather densely covered with numerous species of aquatic plants. Especially abundant is water soldier (*Stratiotes aloides*), a submerged aquatic perennial plant, accompanied by common frogbit (*Hydrocharis morsusraeanae*), which can be a submerged or floating aquatic perennial plant, and common duckweed (*Spirodela polyrhiza*), a perennial aquatic plant usually growing in dense colonies that form a mat on the water surface.

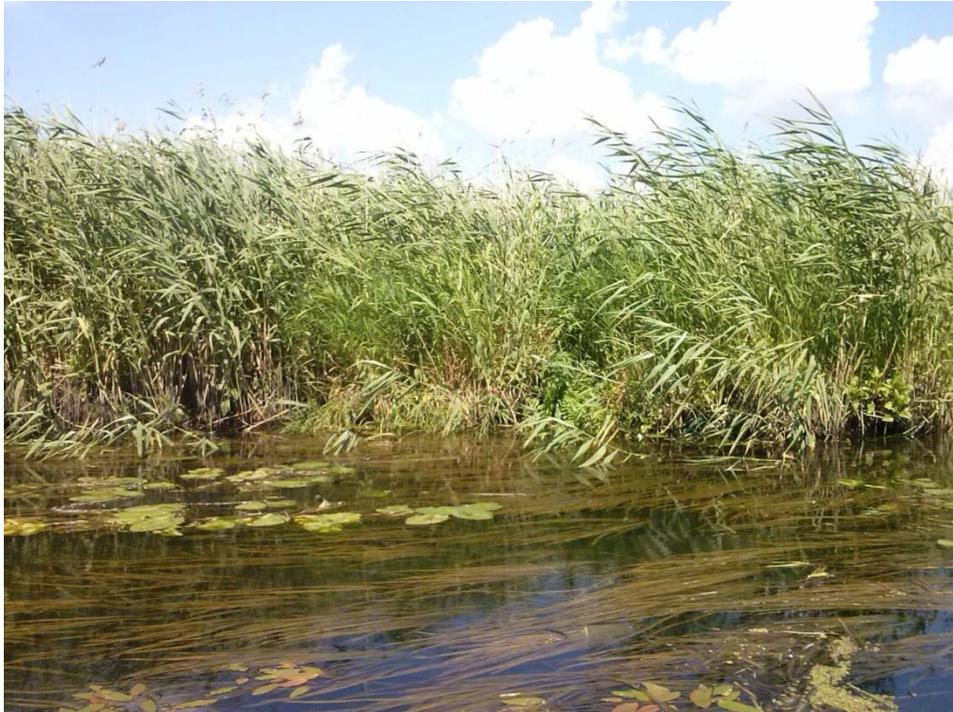
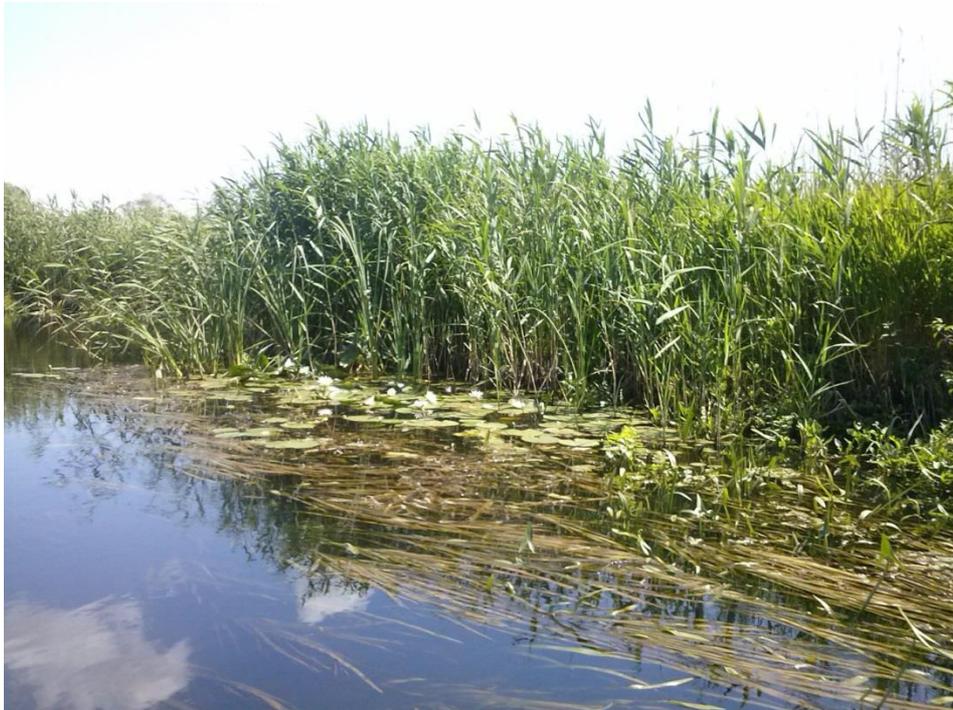
Figure 4.22 Examples of entirely vegetated river banks stabilized by roots of common reed and sedge.

Banks of the anastomosing reaches are usually very steep or nearly vertical and extremely resistant to erosion because of the stabilizing force of peat layer and plant roots (Figure 4.22). Steepness of the banks was supported by 190 cross-sections made in reach 28 and 29 (Figures 4.23, 4.24). Where it does occur, bank erosion is identified by the presence of peat blocks within the channel, however it occurs only exceptionally within the anastomosing reaches in few short sections along the banks (Figure 4.25). It indicates that the protective nature of riparian vegetation, erosion resistance of the peat layer, and low specific stream power result in the negligible lateral erosion of the Narew River channels and lateral stability of the internode reaches of the river. Due to the legal provisions within the borders of the Narew National Park (the major and most restricted form of environmental protection in Polish law), management in the Park is strictly controlled and activities potentially harmful to the environment are forbidden. On the

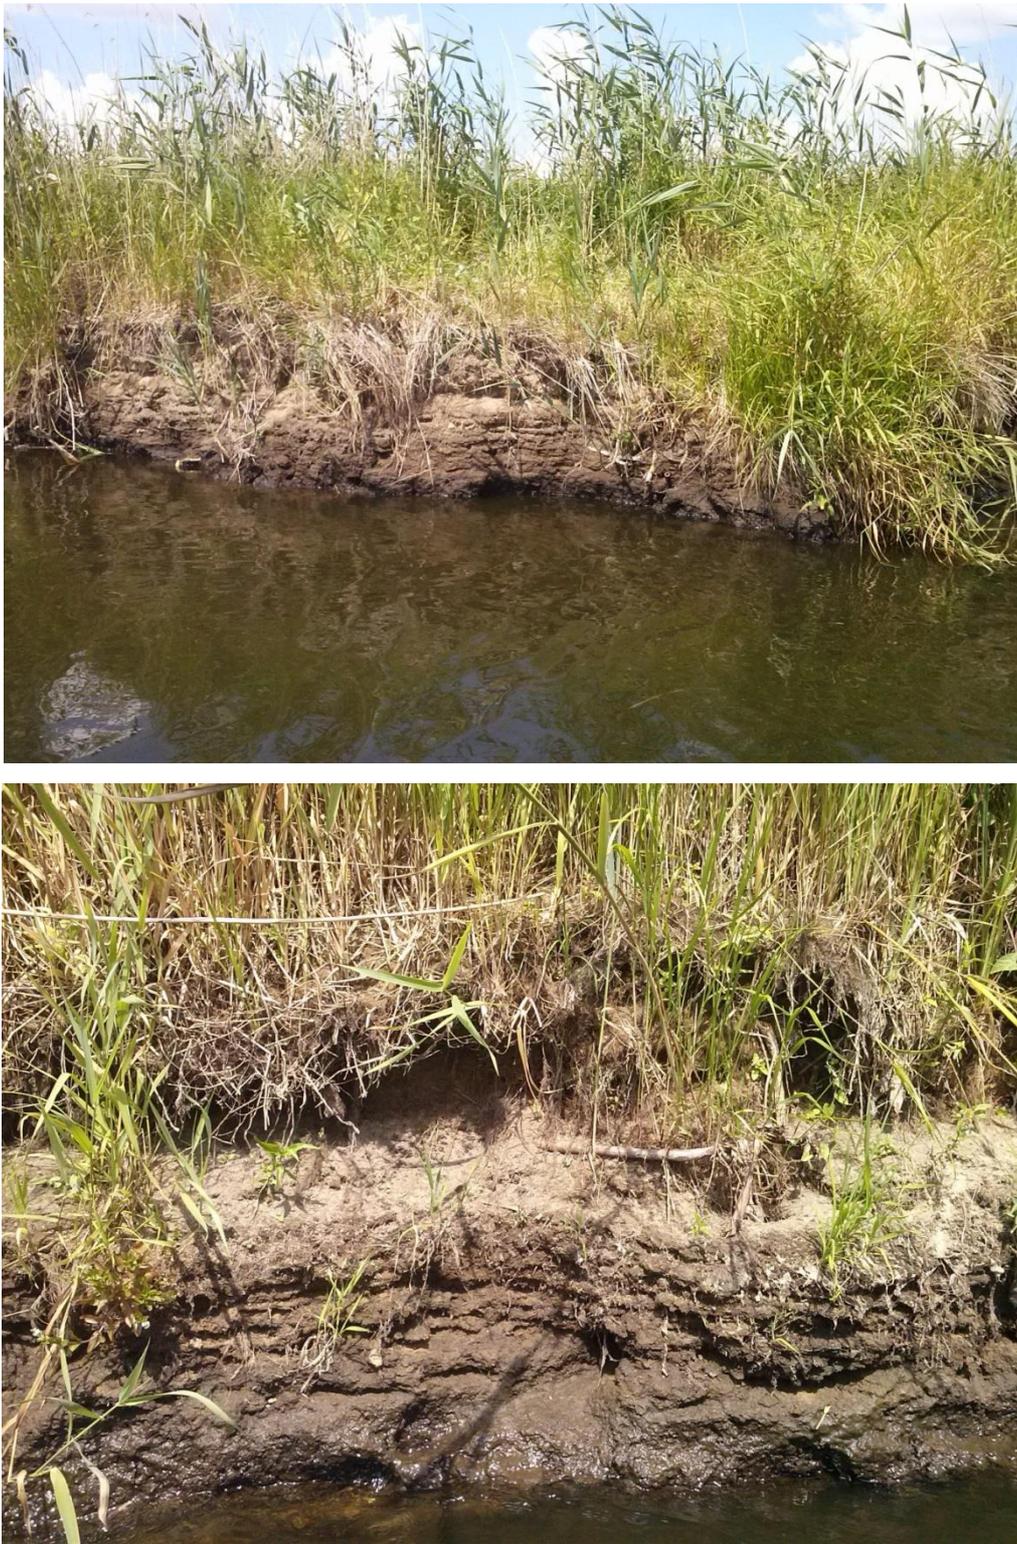
Figure 4.25 Examples of local erosion of the peat banks (evidenced by overhanging grass roots).

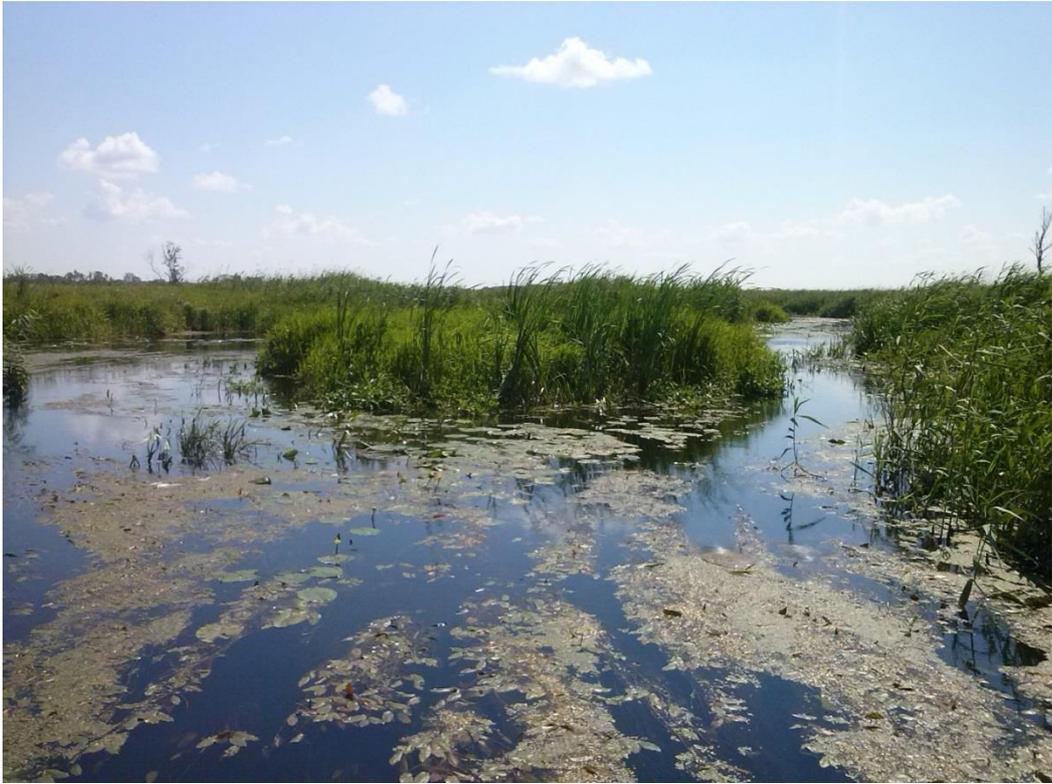
Figure 4.28 An example of a mid-channel vegetated bar in reach 29.

The analysis of emergent sediment features was conducted using aerial imagery. The total number of inventoried geomorphic features per reach is presented in Figure 4.26. The average numbers of any reported feature in analysed reaches were calculated and scaled to km to yield the number of features per km (Figure 4.27). Figure 4.28 illustrates a completely vegetated mid channel island.

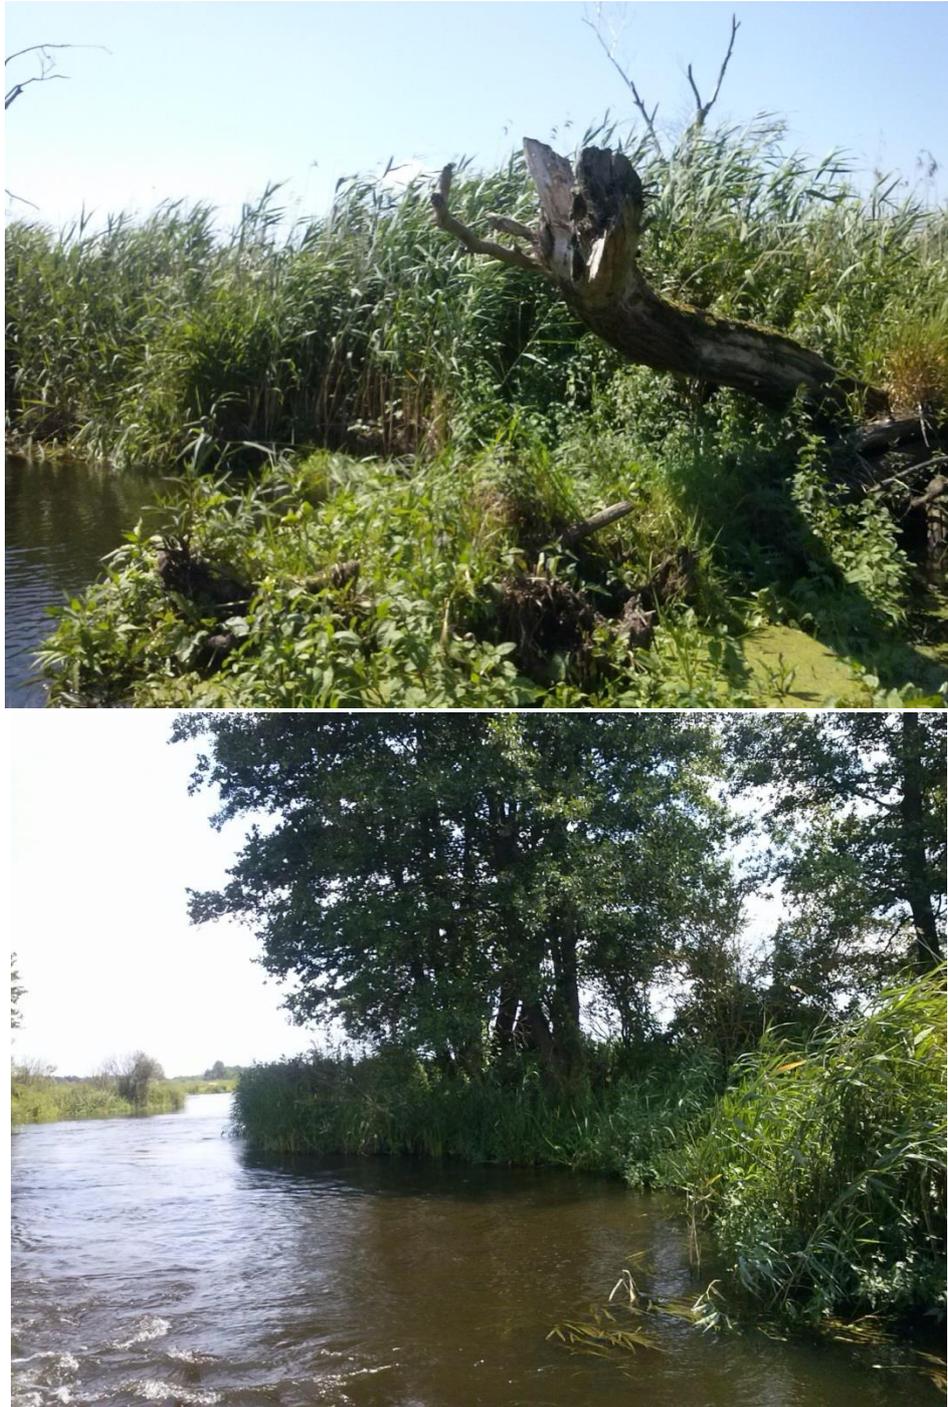
Figure 7.2 Examples of presence of single trees near the channels (Reaches 28, 29).

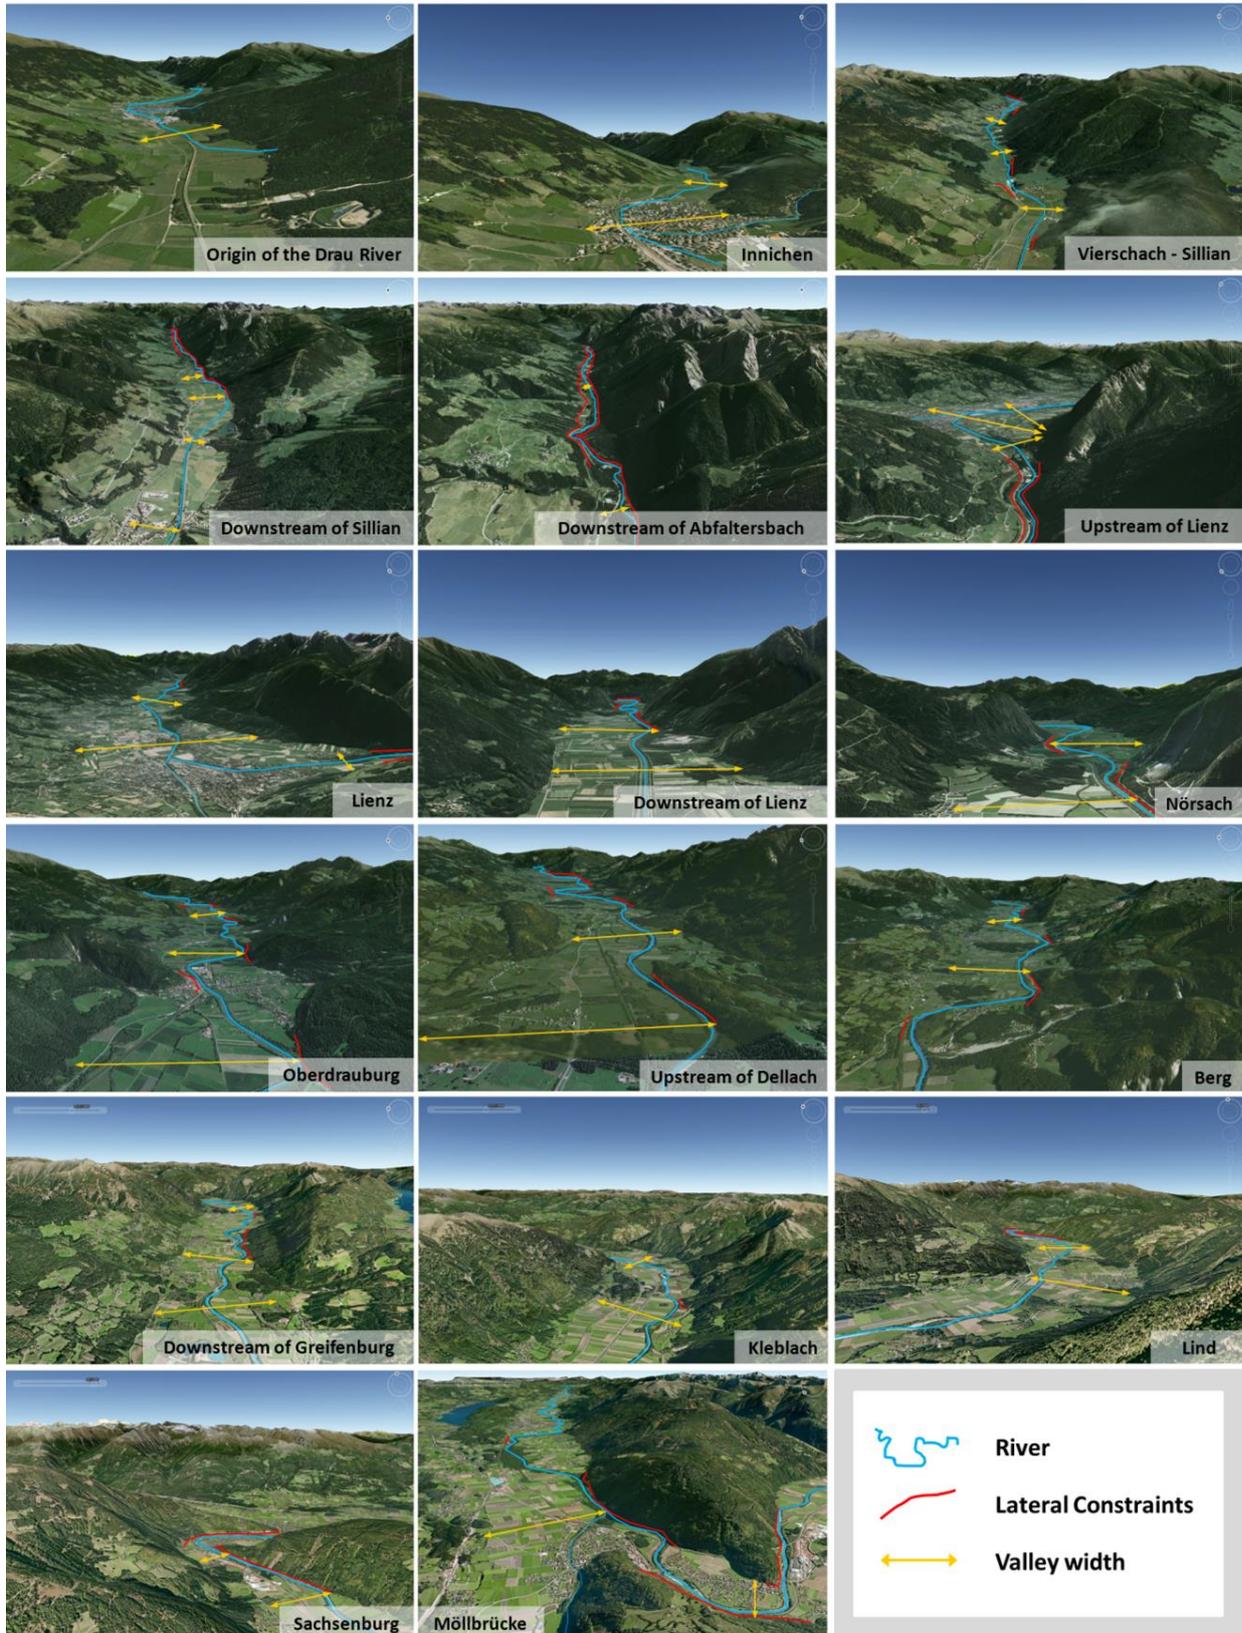
Figure 3.12 Visualisation of the confinement of the Upper Drau river (from source to Sachsenburg, where the Drau River conflues with the Möll River). Views are in the direction of flow (source: Google Earth).

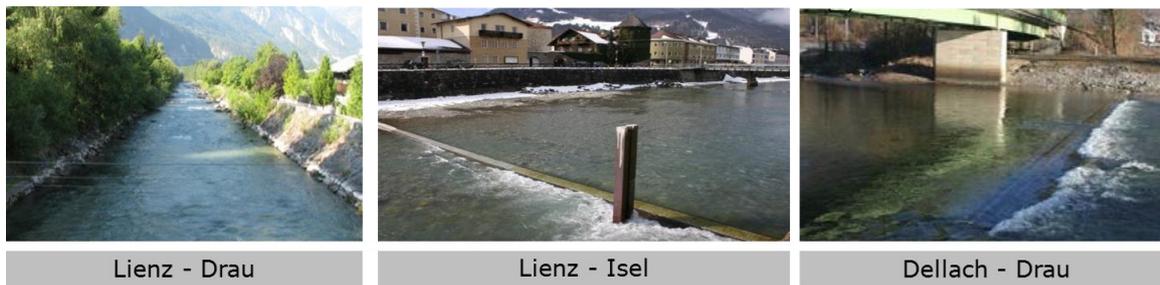
Figure 4.39 Bed load monitoring stations in the Upper Drau basin at Lienz (River Drau and River Isel) and at Dellach (Drau River).

Three bed load monitoring stations are located within the investigated catchment area (Figure 4.39). Two of the stations are located in Lienz, one on the Drau and one on the Isel River. The third station is located several kilometres downstream of Lienz, in Dellach. Some characteristics of the monitoring stations are given in Table 4.6. Each monitoring station is equipped with geophones, and bed load measurements are carried out with mobile basket samplers. In addition, three bed load traps are installed at the monitoring station at Dellach. In Figure 4.40 and Table 4.7, summary bed load measurements (e.g. specific bed load rate, grain size distribution and characteristic grain sizes) are presented.

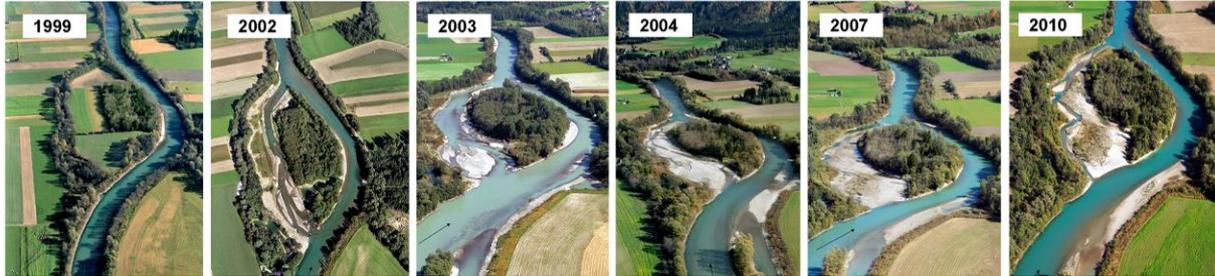
Figure 5.13 Development of the river restoration at Kleblech from 1999 till 2010 (pictures: Amt der Kärntner Landesregierung).

In this section only reaches 2.10 (regulated reach - Berg) and 2.18 (restored reach – Kleblach) are considered. Since the regulation works in the last century, the planform and channel geometry of reach 2.10 have not been changed. As shown in Figure 5.6 (section 5.2), an increase in water levels at low flow occurred over the period 1991 to 2013. The changes in the river planform of reach 2.18 are presented in Figure 5.13. In the regulated condition (before 2001) the river type was single thread. The restoration works included the installation of two side channels and river bed widening at several locations.

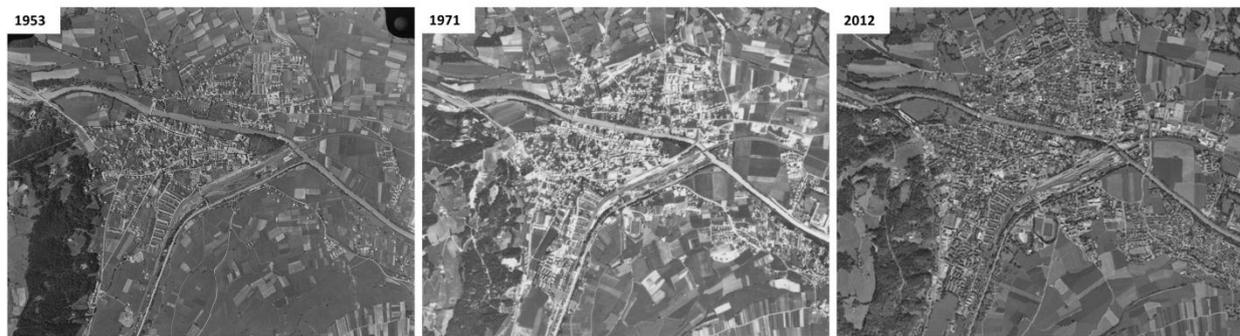
Figure 6.1 Increase in urban and industrial, commercial and transport units, Lienz (<https://portal.tirol.gv.at/LBAWeb/luftbilduebersicht.show>).

Over the last 50 years (1950 to 1995), artificial surfaces and forested areas have increased (Krausmann et al., 2003). For example, the settlement area of the city Lienz has expanded greatly over the last 60 years (Figure 6.1).

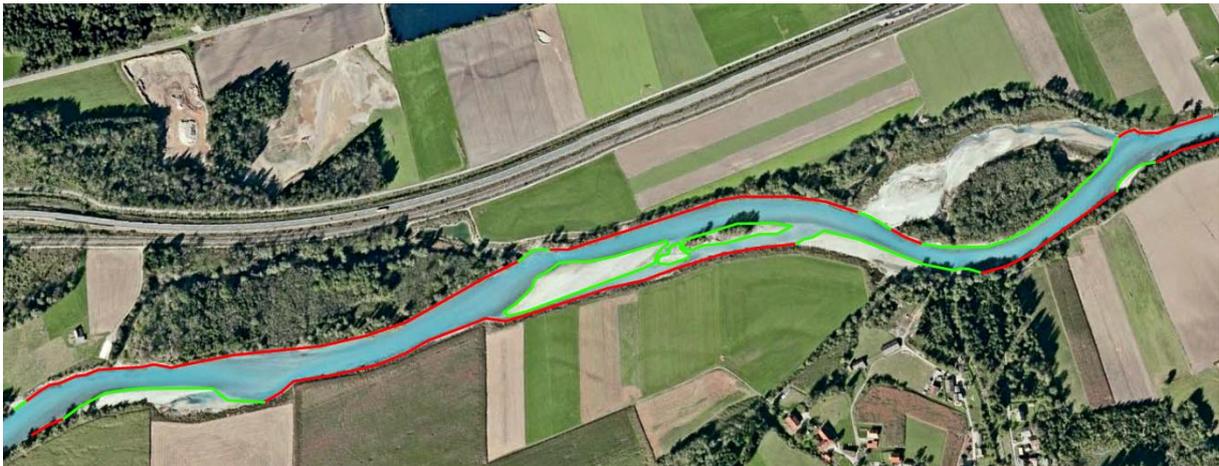
Figure 7.6 Bank protection constraining the flow at mean discharge in the evaluated reach (restored state in 2008).

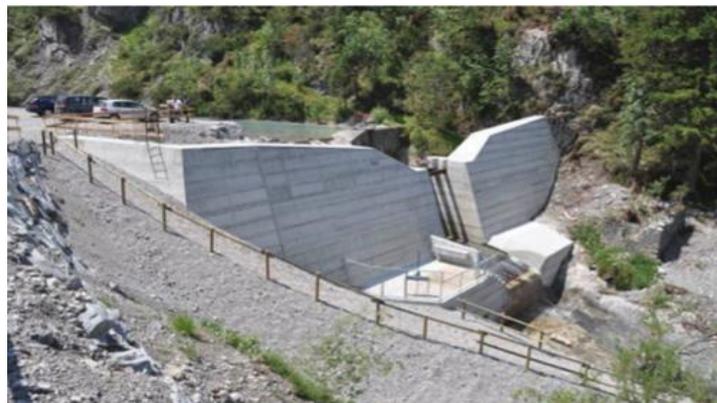
Figure 8.4 New torrent control at the Feistritzbach (picture: WLW).

At the Feistritzbach River, a tributary to the Drau, an old torrent control was demolished and a new one, which allows self-dynamic clearance during lower flow situations, was constructed (Figure 8.4). By this measure, an increase in the sediment throughput has had been achieved.
