## [River Vääräjoki - Finland, Flagship restoration measure](#) [1]

Niskakoski is one of the riffle sections in the River Vääräjoki where in-stream restoration measures were conducted in late 1990s. The river is altogether 107 km long and descends 110 metres from its origins to the point where it reaches river Kalajoki. Most riffle sections of the mid reach were restored from channelization for timber transport and flood protection, but the riffles in upper and down reaches of the river are still channelized. There are plans to continue the restoration work and restore the old riffles also at other reaches. Water quality of the river is deteriorated due to considerable human activities in the catchment (particularly forestry and agriculture).

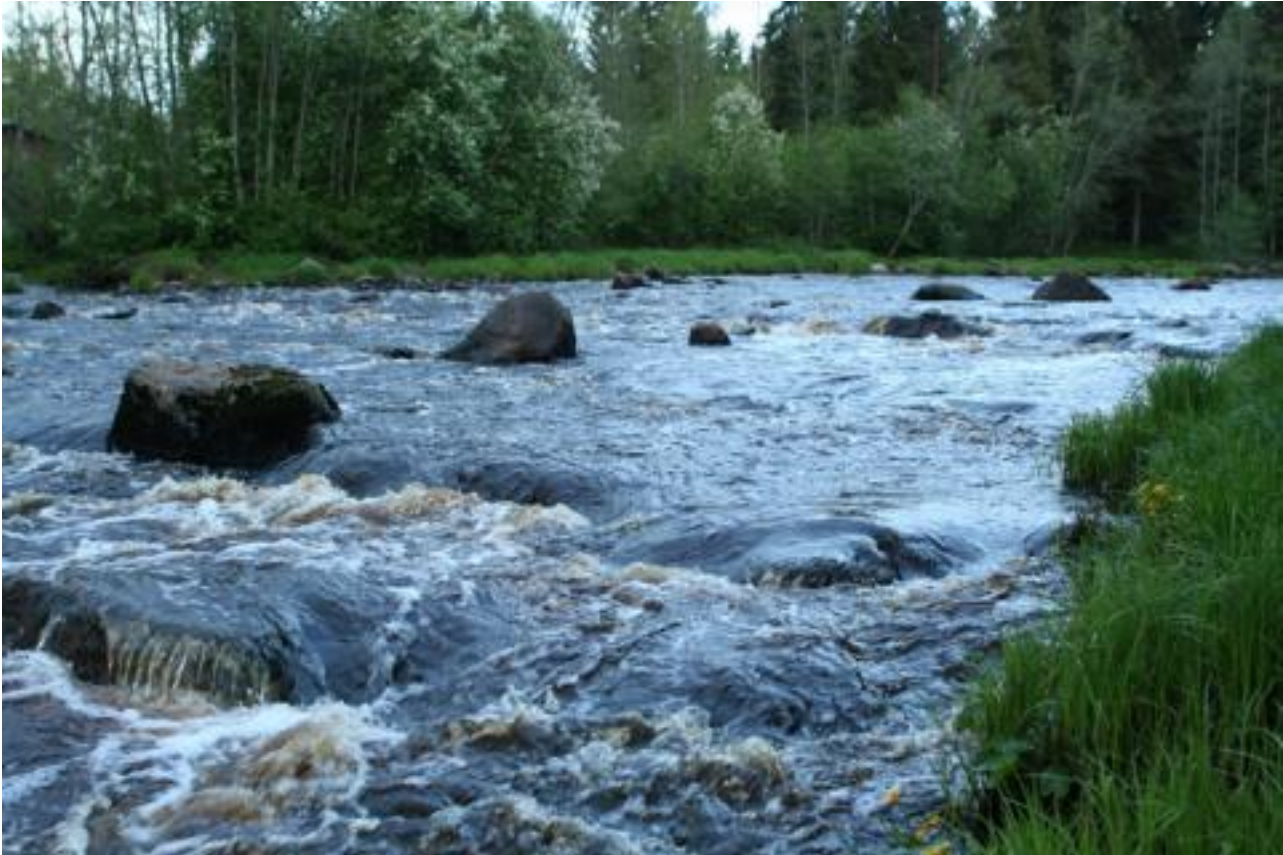
- In-stream restoration measures were conducted in late 1990s to enhance stream habitat diversity: The stream bottom was rearranged using boulders that were removed from the channel and placed along stream margins during channelization. Also gravel beds were created to provide nursery habitat for salmonids.
- **Length of restoration:** Altogether over 5 km of the river was restored in 1997-2006 (consisting of multiple riffle sections).
