Restoring the channelized River Vääräjoki (Finland) towards good ecological status

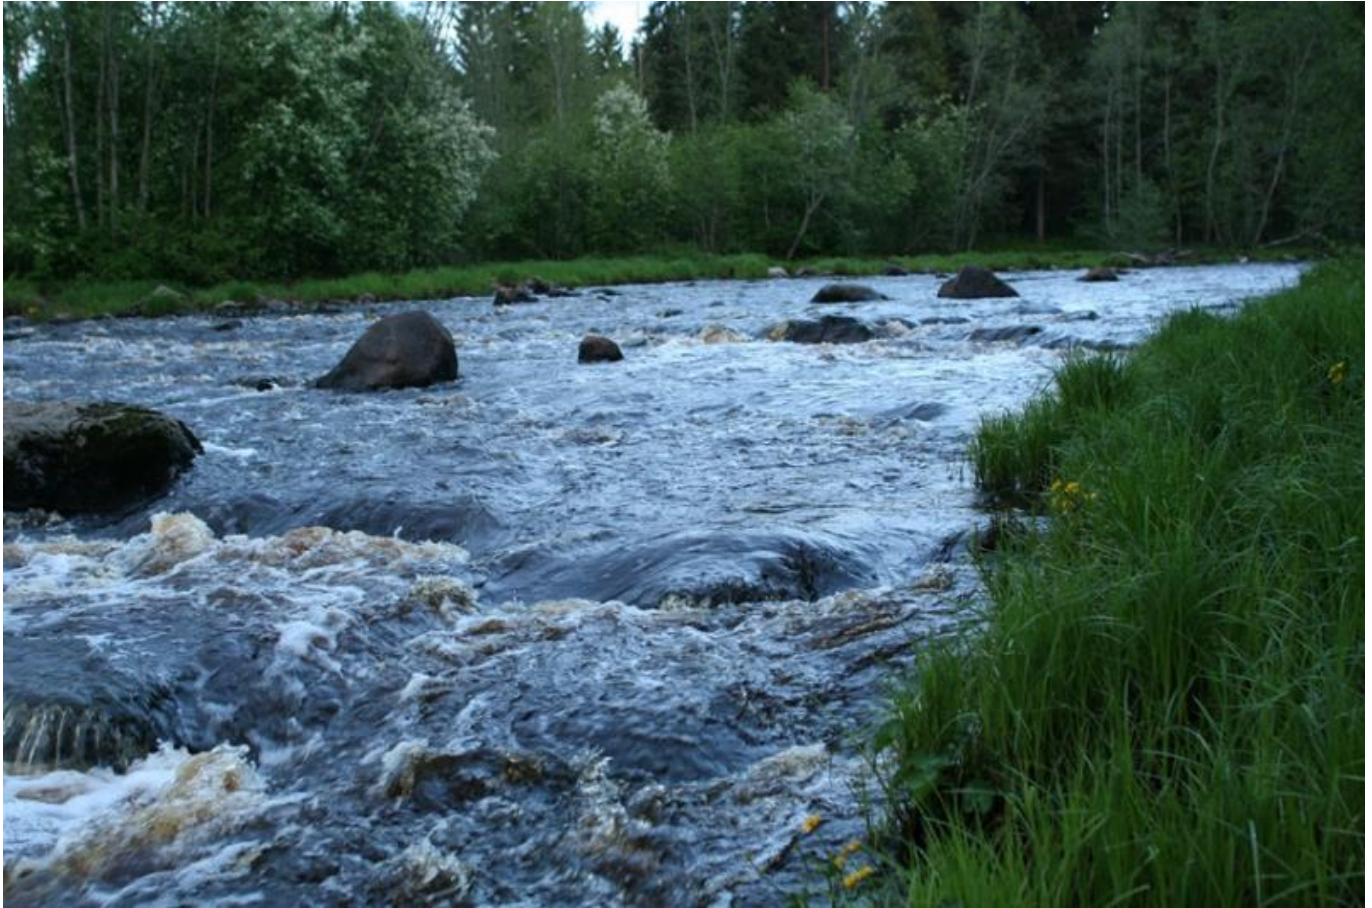
Figure 3. The restored riffle Niskakoski at Vääräjoki. Photo: Jukka Aroviita.

Nowadays, all rapids in the section from 13 km to 29 km upstream of the river mouth have been restored. These extensive works were started in late 1990s and were finished in 2006. The main aim has been to return the heavily modified river closer to its natural hydrological and morphological state and particularly to enable fish migration and spawning. The stream bed was rearranged using boulders that had originally been removed from the channel during channelization and placed along stream margins (Figure 3). Also, gravel beds were created to provide nursery habitat for salmonids.
