## Restoration of longitudinal connectivity and salmonid habitat in River Mörrumsån (Sweden)

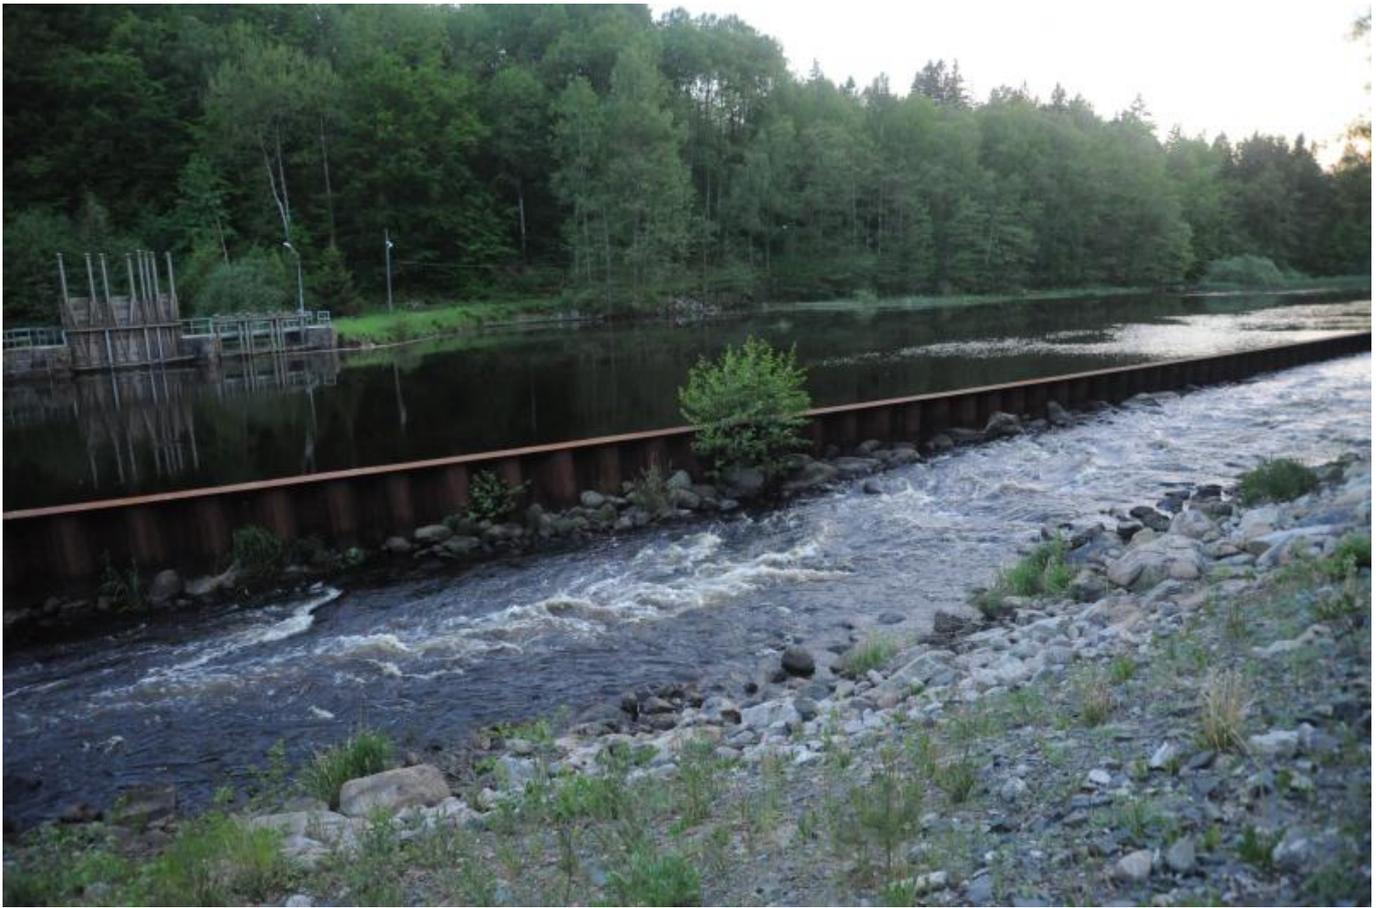
**Figure 2.** Nature-like partial width rock ramp constructed at Hemsjö nedre hydropower dam in River Mörrumsån in 2003-2004. Photo by Frauke Ecke, SLU.

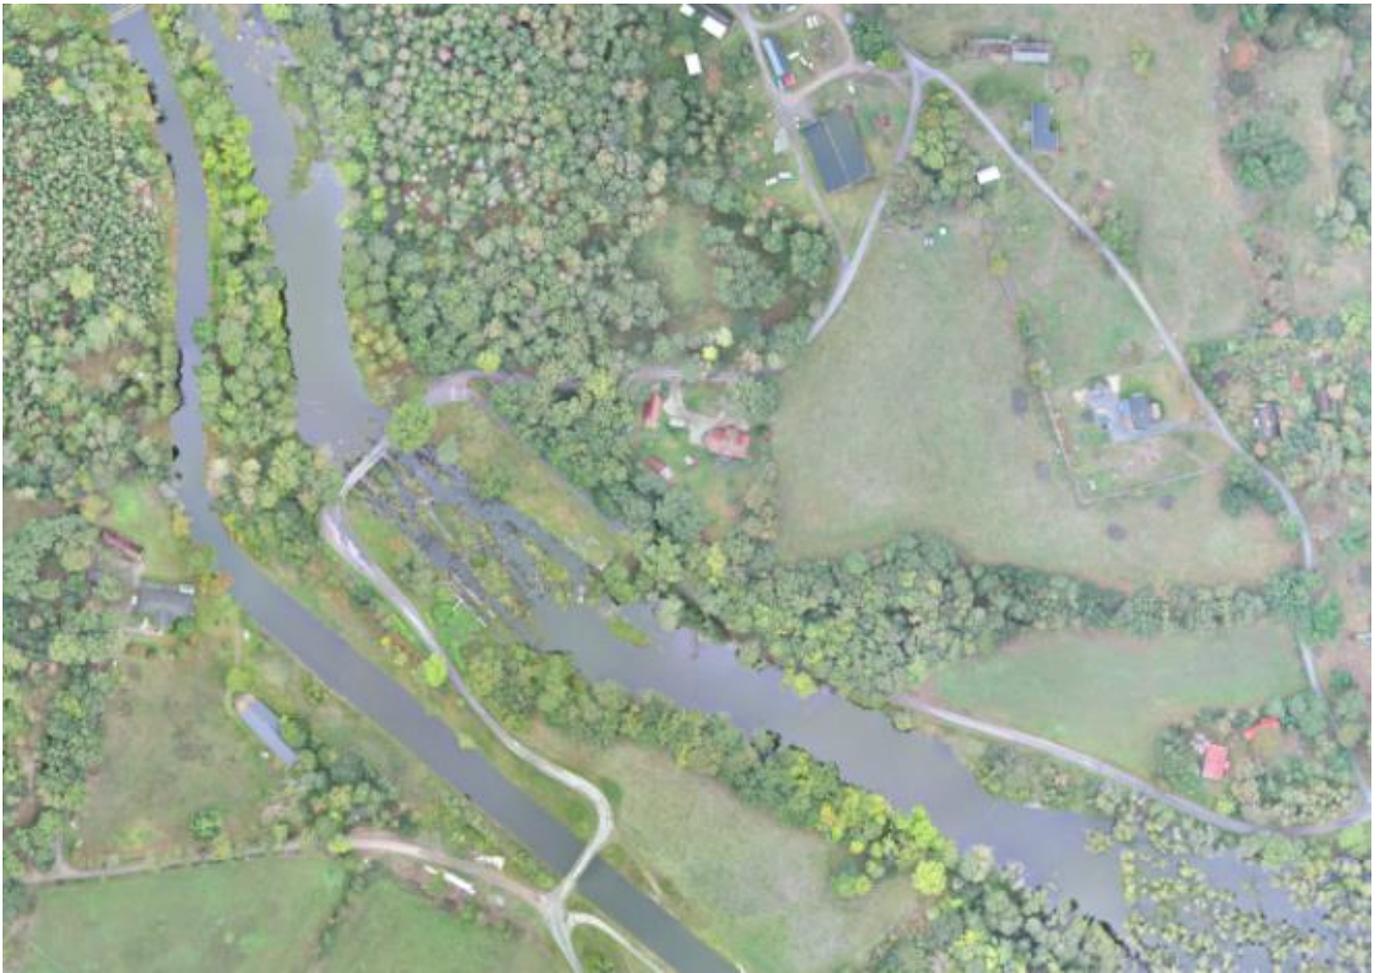
**Figure 3 + Figure 4:** Overview of parts of the restored stretch in River Mörrumsån (left), also visible is the man-made channel feeding the Hemsjö övre hydropower station. To the right a photo of a restored stretch during a flow episode when more than the dictated minimum flow of 1 m<sup>3</sup>/s has been directed through the natural channel. Salmonid spawning gravel was added here in 2010. Photos by Frauke Ecke, SLU.

The cost for these restoration measures and the reduction of hydropower output in the affected stations was shared by the partners of the interest group. The River Mörrumsån Fish Conservation group has remained active after the initial restoration measures. This has facilitated e.g. the installation of automatic fish counters at the Marieberg and Hemsjö övre fishways as well as the addition of hundreds of cubic meters of salmonid spawning gravel to areas in the former dry channel between Hemsjö nedre and Hemsjö övre and to other stretches of the river in 2004, 2005, 2006, 2010 and 2012 (figures 3 and 4).
