## [River Storå - Denmark, Small restoration measure \[1\]](#)

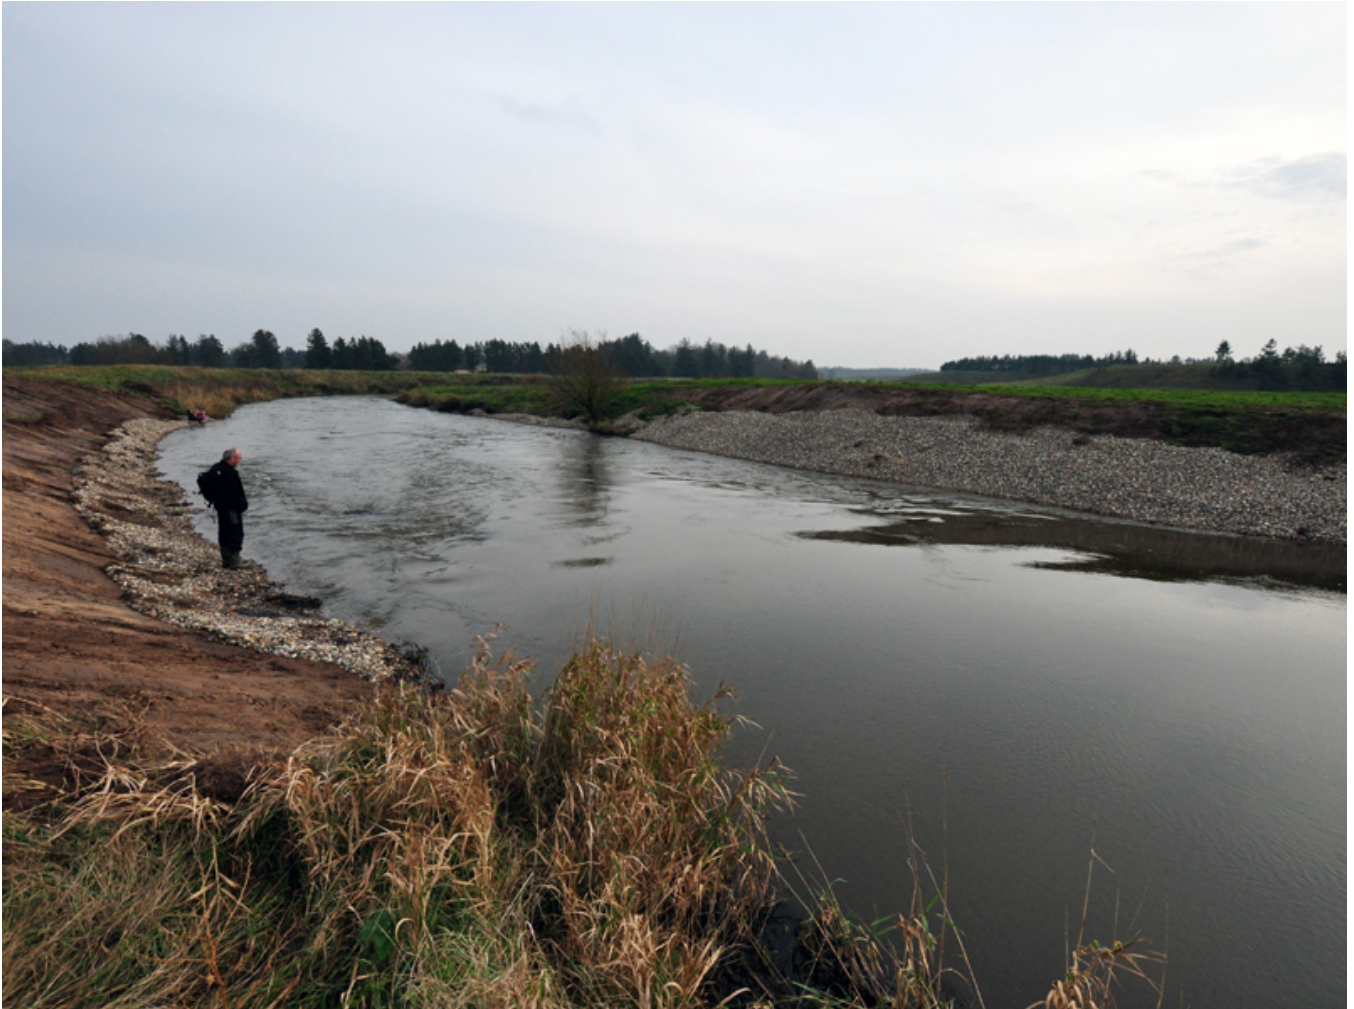
River Storå is the 3<sup>rd</sup> largest river in Denmark and drains the western part of the peninsula Jutland. Parts of the river were channelized during 1950's however large reaches of the river have also been left untouched. Smaller reaches of the river have been restored, including addition of coarse material for improving salmonid spawning.

- **Typology:** Mid-sized lowland river
- **Altitude:** 20 m
- **Catchment area:** 1,100 km<sup>2</sup>
- **Pressures before the restoration:**
  - straightened river course
  - degradation of river bed
  - hydropower
  - barriers
- **Restoration measures conducted:**
  - addition of coarse material
- **Length of restoration:** 0.5 km
