[River Lahn - Germany, Small restoration measure](#) **[1]**

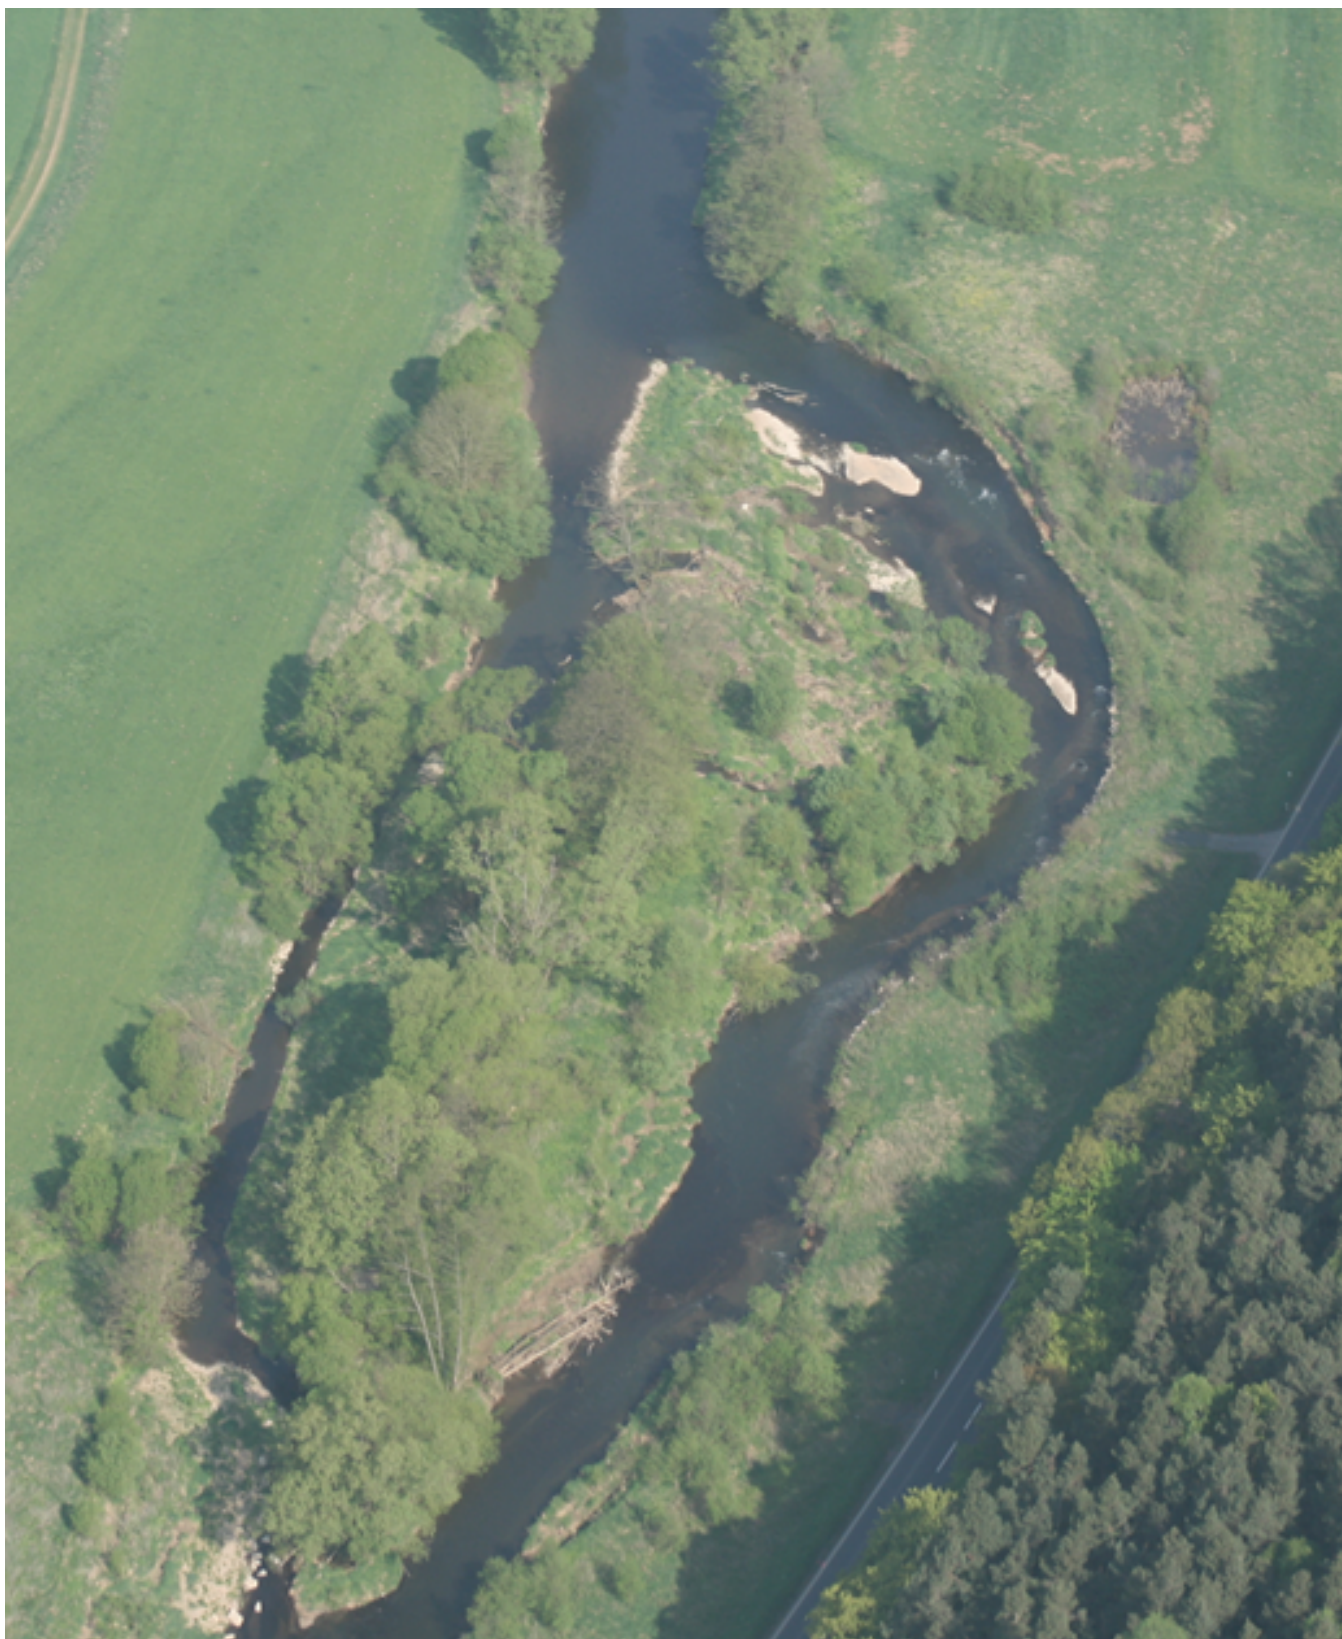
The restored site Cölbe in the river Lahn is located in the Federal State of Hesse. The river section belongs to the 'Auenverbund Lahn - Ohm' set up for the protection and natural development of the floodplains and tributaries of the rivers Lahn and Ohm. It serves as an important area for characteristic species, flood prevention, local recreation and the local climate. Restoration measures were implemented in 2000 on a river length of 200m. The main aim was a morphological improvement as the river course was straightened and natural instream habitats were largely missing. Therefore, bank fixations were removed to initiate bankside erosion and the river bed and banks were restructured to enhance habitat and biotic diversity.

- **River:** Lahn
- **Site name:** Cölbe
- **Typology:** Mid-sized mountain river
- **Altitude:** 191 m
- **Catchment area:** 650 km²
- **Pressures before the restoration:**
 - stabilised river banks (riprap)
 - straightened river course
 - monotonous cross profile
- **Restoration measures conducted:**
 - removal of bank fixation to initiate bankside erosion
 - creation of a side arm
 - restructuring of river bed and banks
 - placement of large wood
- **Length of restoration:** 0.24 km
