River Becva – Czech Republic, Flagship restoration measure

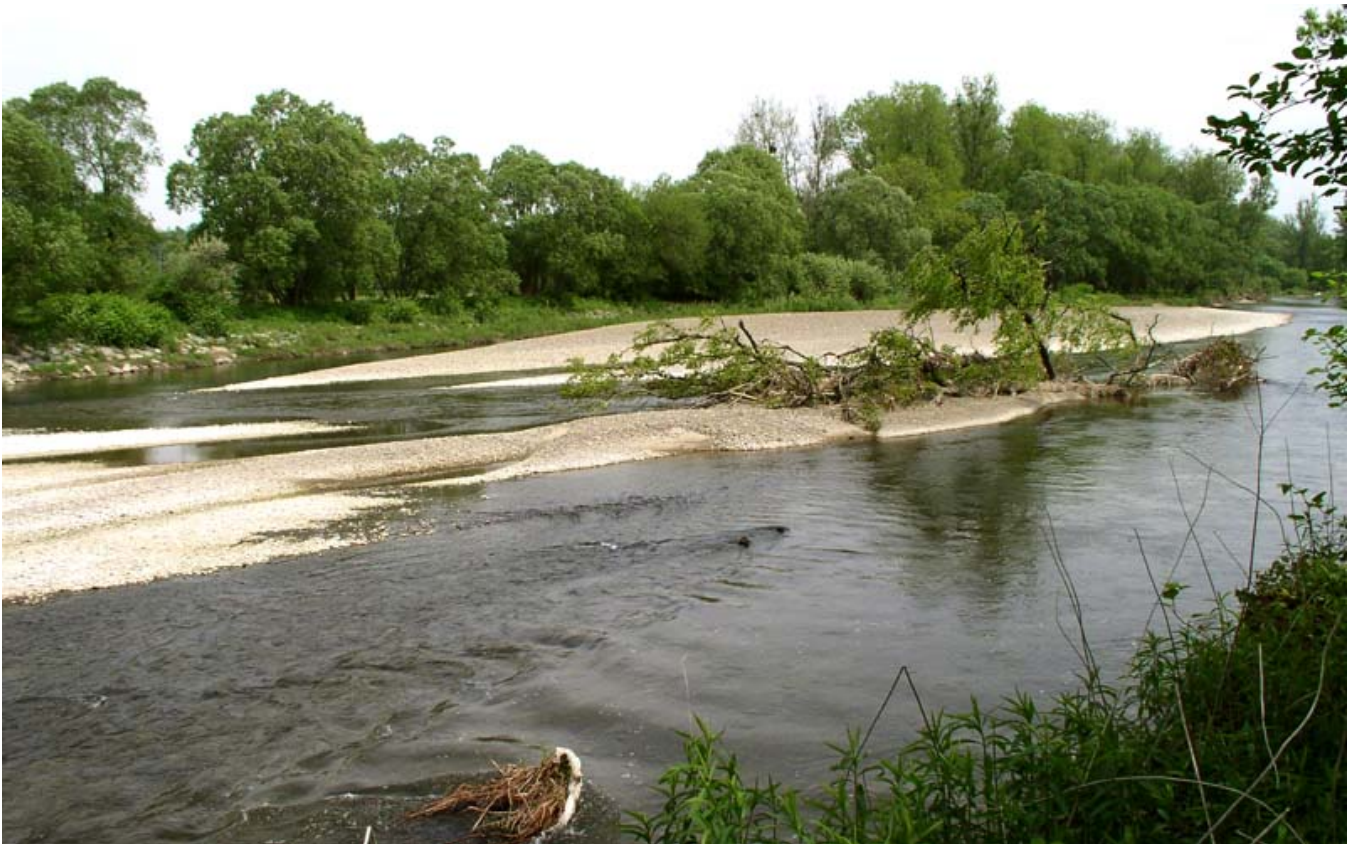
Natural braided channel pattern and high dynamics of gravel-bed channel were altered by channelization project at Becva River in years 1902-1935. The case study site is one of five river stretches which were renaturalized by floods in 1997. In comparison with regulated channels (uniform channel width, reinforced banks) the restored section is characterized by intensive erosional and depositional processes. Wider channel and intermittent occurrence of large woody debris in channel contribute to the development of hydromorphological features characteristic of braiding channel style (bars, side lateral channels/pools). Higher heterogeneity of river habitats was documented in terms of water chemistry, water temperature, substrate and aquatic biota.
