## **The River Narew (Poland) has it all being in part natural, regulated and restored**

The Narew River is one of the case studies of REFORM aiming to assess the interaction between restored stretches and the status of the wider catchment.

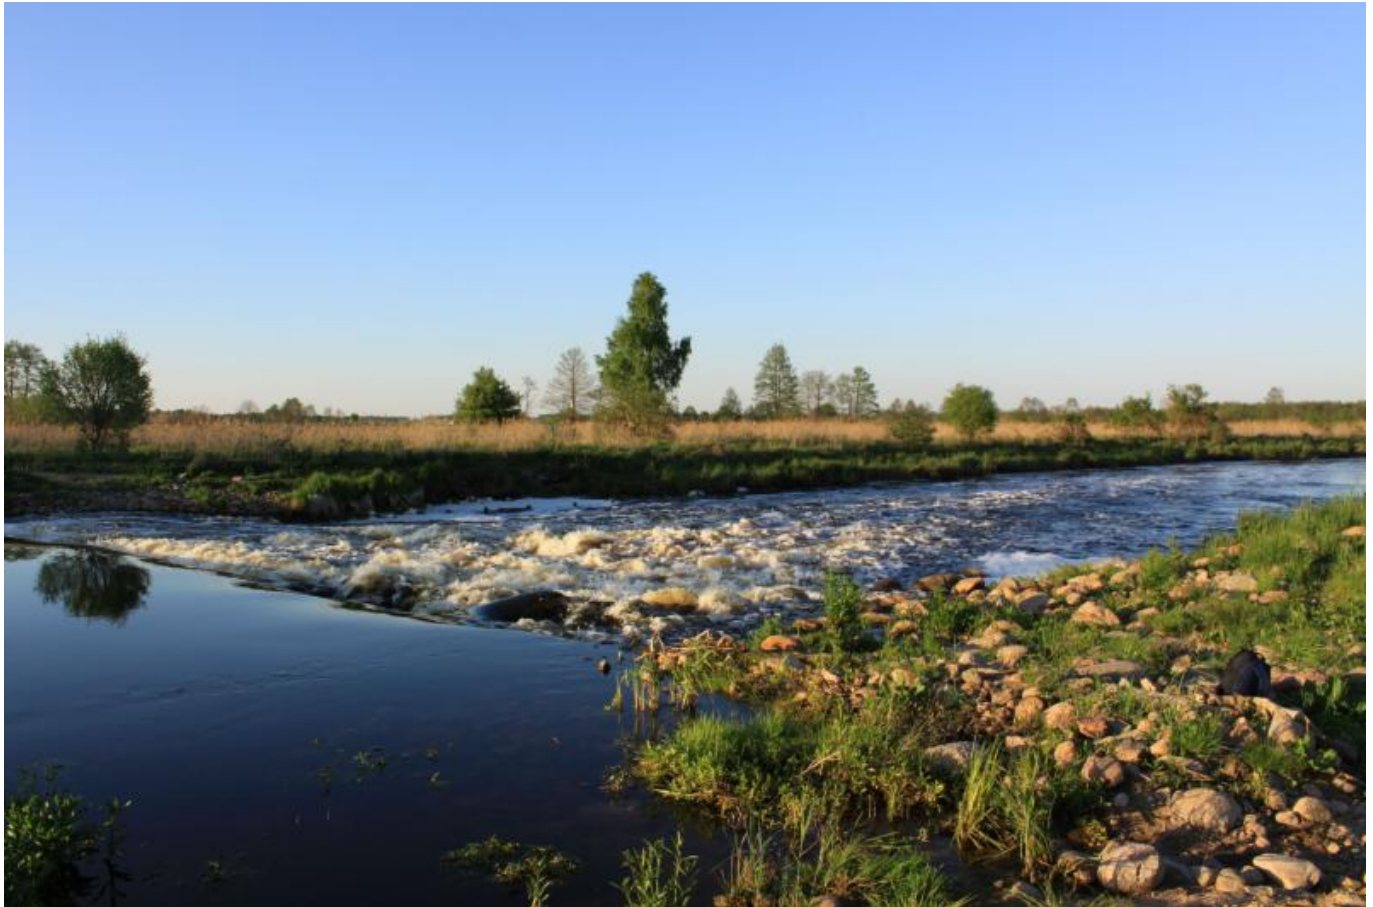
Photo: Grasslands in the regulated section of Narew (Tomasz Okruszko)

In the late 1970s, a reach of the River Narew between the village of Kolonia Rzędziany and the junction with the Biebrza River has been engineered. As a result, the network of multiple channel belts was replaced by one deep channel. The grasslands and meadows replaced the wetland ecosystems. Contrarily, the upstream part of the Narew River still consists of multi-channel riparian wetlands which in 1996 became a protected area called the Narew National Park (NNP; [www.npn.pl](http://www.npn.pl)). However, hydrological alterations in the regulated stretch led to the decrease of the groundwater level in the NNP favouring common reed expansion and shrubs encroachment causing a loss of ecosystem biodiversity.

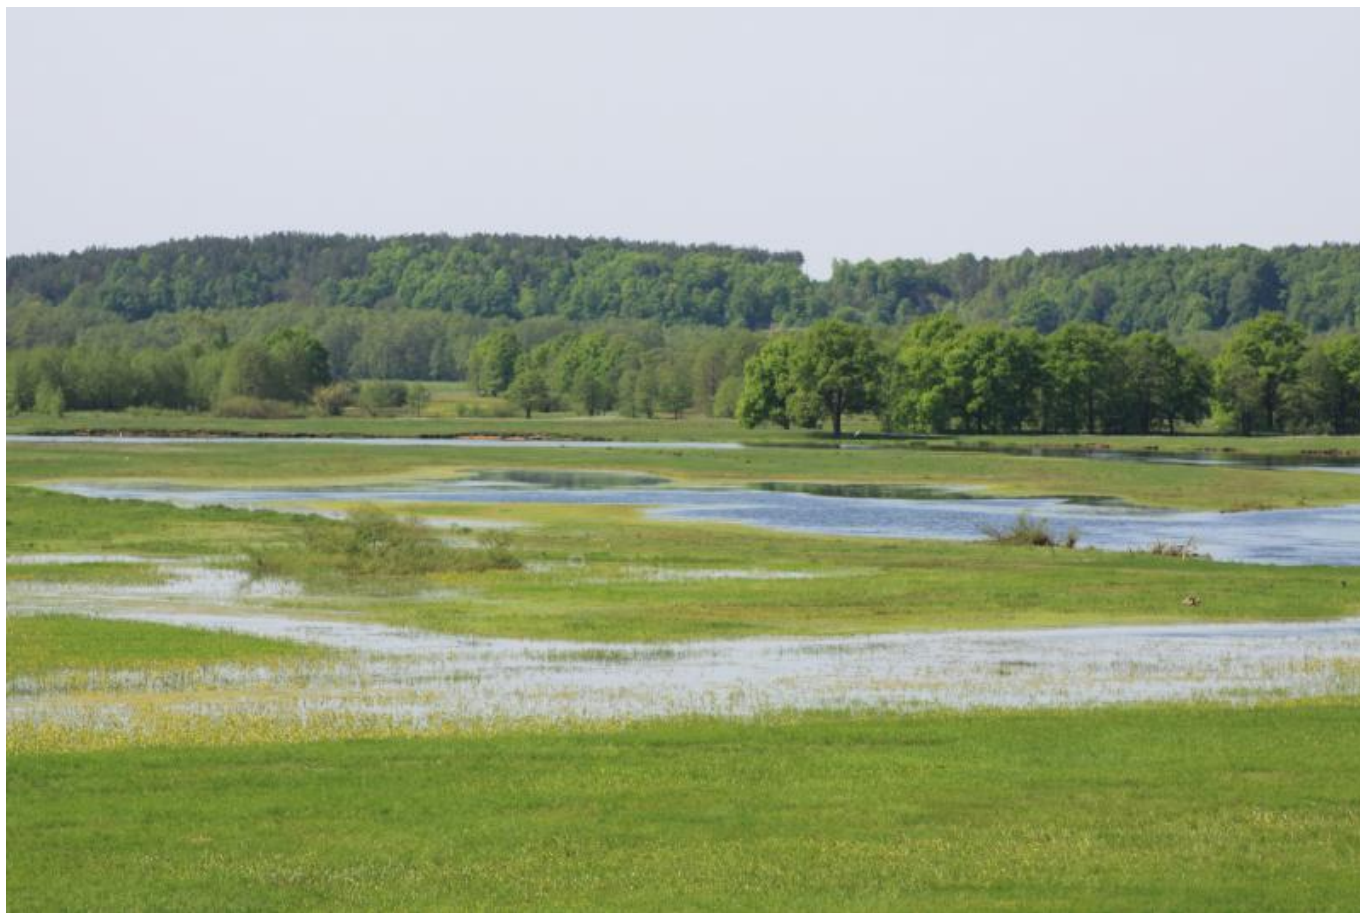
Photo: Rapid increase of the water level in the buffer zone (Tomasz Okruszko)

In the early 1990s, the Polish Bird Protection Association (PTOP) initiated a project focused on restoration of partly natural conditions in a so called buffer zone i.e. between the park and intensive grasslands. First restoration works began in 1996 on the oxbows near the village of Rogowo. In the period 1996-2001 the oxbow lakes were cleared and the shrubs, mud deposits, reeds and their parts were removed. The next step was the construction of new river channels through the Rzędziany-Pańki dike (which is the border between park and grasslands) aiming to restore the multi-channel system. The first of two stone rapids in the main artificial channel was constructed in 2007 and the second was finished in 2010. The aim is to increase the water level in the downstream part of the park. Farmers in the surrounding area have strongly protested against the construction of rapids. The area exposed to restoration works is situated in the northern part of the NATURA 2000 PLB200001 site called Bagienna Dolina Narwi (the Wetland Narew Valley) stretching between the
