REFORM

REstoring rivers FOR effective catchment Management

Deliverable Deliverable 2.1 Part 4
Title Catchment Case Studies: Partial Applications of the Hierarchical Multi-scale Framework
Author(s) (authors of part 4 in alphabetical order*) B. Blamauer¹, B. Camenen², R.C. Grabowski³, I.D.M. Gunn⁴, A.M. Gurnell³, H. Habersack¹, A. Latapie², M.T. O'Hare⁴, M. Palma⁵, N. Surian⁵, L. Ziliani⁵
¹BOKU, ²IRSTEA, ³QMUL, ⁴NERC, ⁵University of Padova

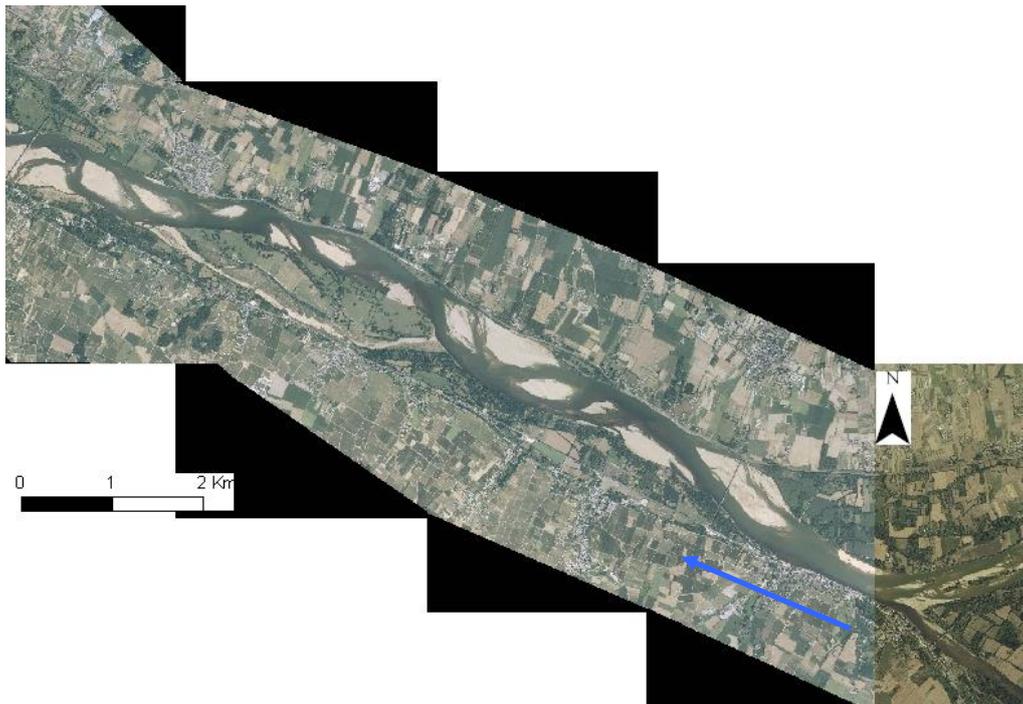
Figure 3.13 Delineation of reach E (photo 2005 and 2002, DREAL Centre).

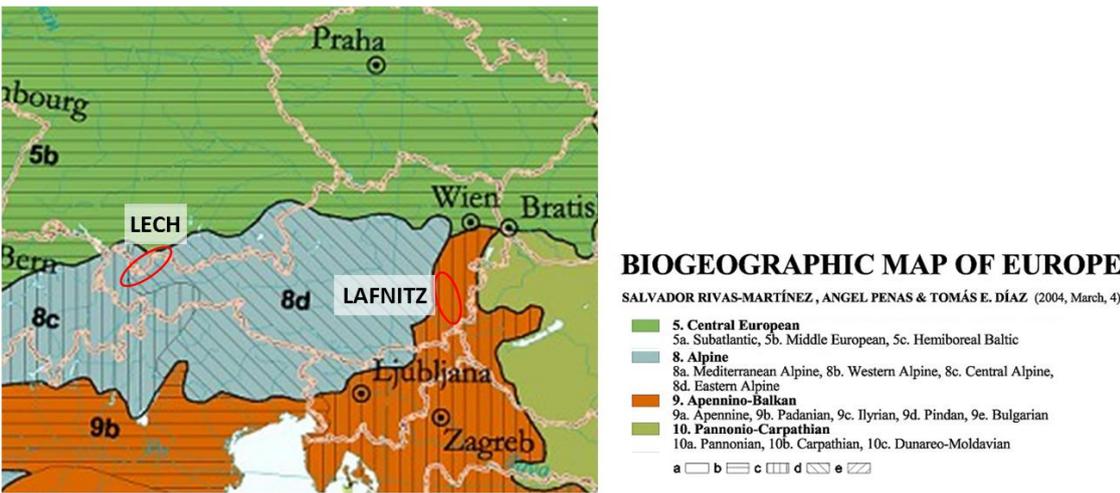
Figure 4.1: Biogeographic regions of Austria (Rivas-Martínez et al., 2004b).

The entire catchment of the Lech River is located in the Eastern Alpine biogeographic region (Figure 4.1) and the bio-climate can be classified as temperate oceanic (Figure 4.2).

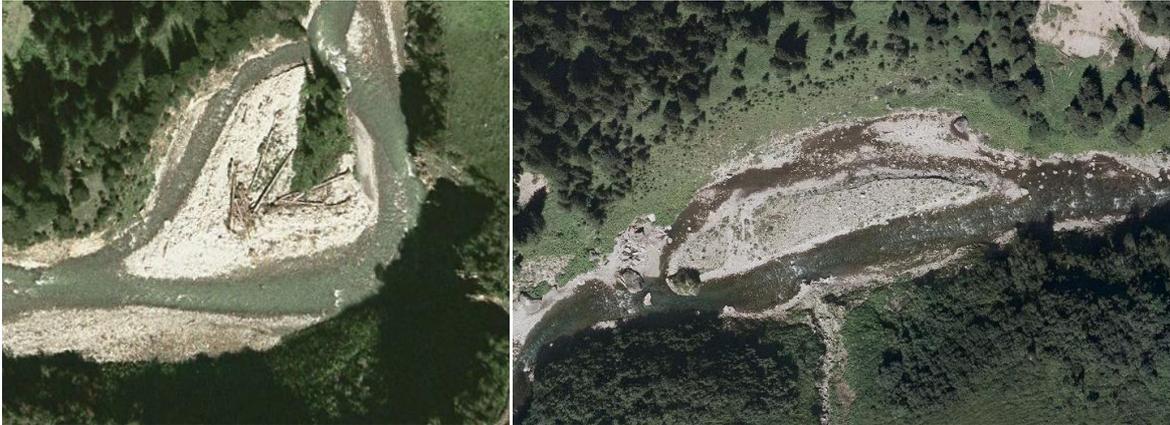
Figure 4.37 Small braiding sections with (left) and without (right) vegetation on the bars (VoGIS, 2013).

Segment 5: Like segment 4, segment 5 is located in a confined section of the Upper Lech, and the vegetation patches are quite similar to the previous segment.

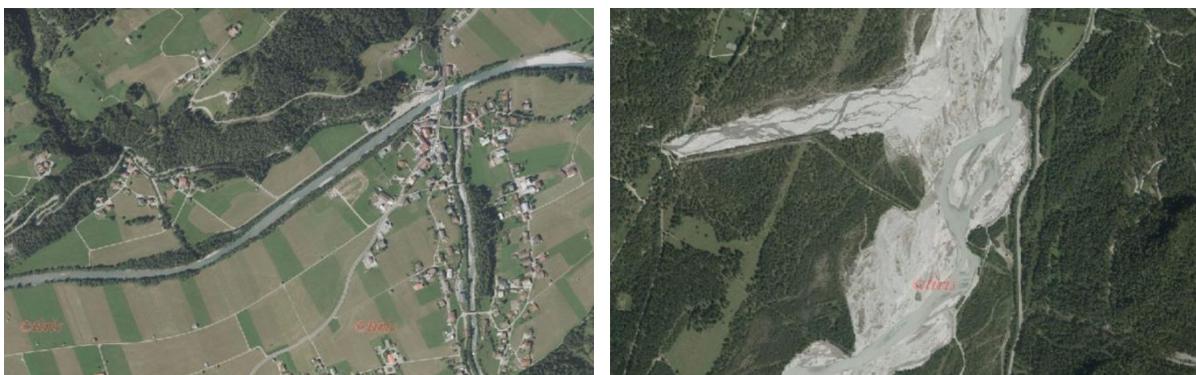
Figure 4.38 Upstream (left) and downstream (right) section of segment 8 with different extents and structure of floodplain vegetation (TirisMaps, 2013).

Segment 8: The upstream part of segment 8 is similar to segment 7, but the downstream section is characterized by larger lateral extents of the floodplain (Figure 4.38). The structure is less homogeneous and the densities vary. On some bars vegetation patches are present.

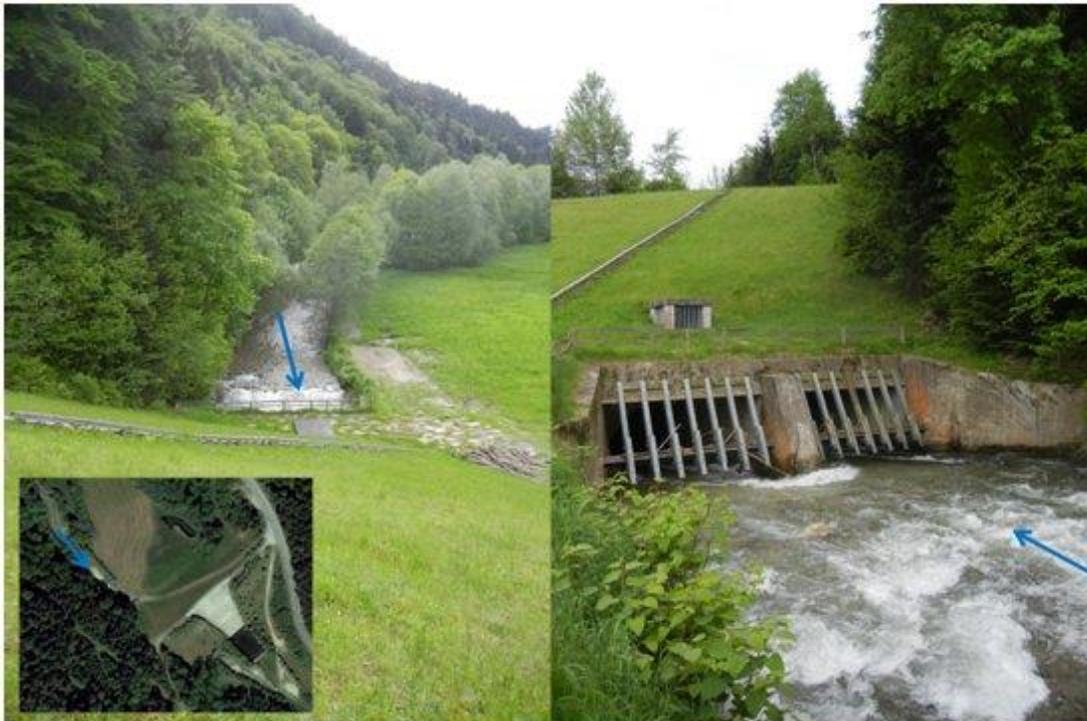
Figure 4.71 Retention basin St. Lorenzen – Riegersberg (data source plan view: GoogleEarth, 2013)
